Monitoring and outcomes

20 years of The Living Murray
Much achieved, much to do

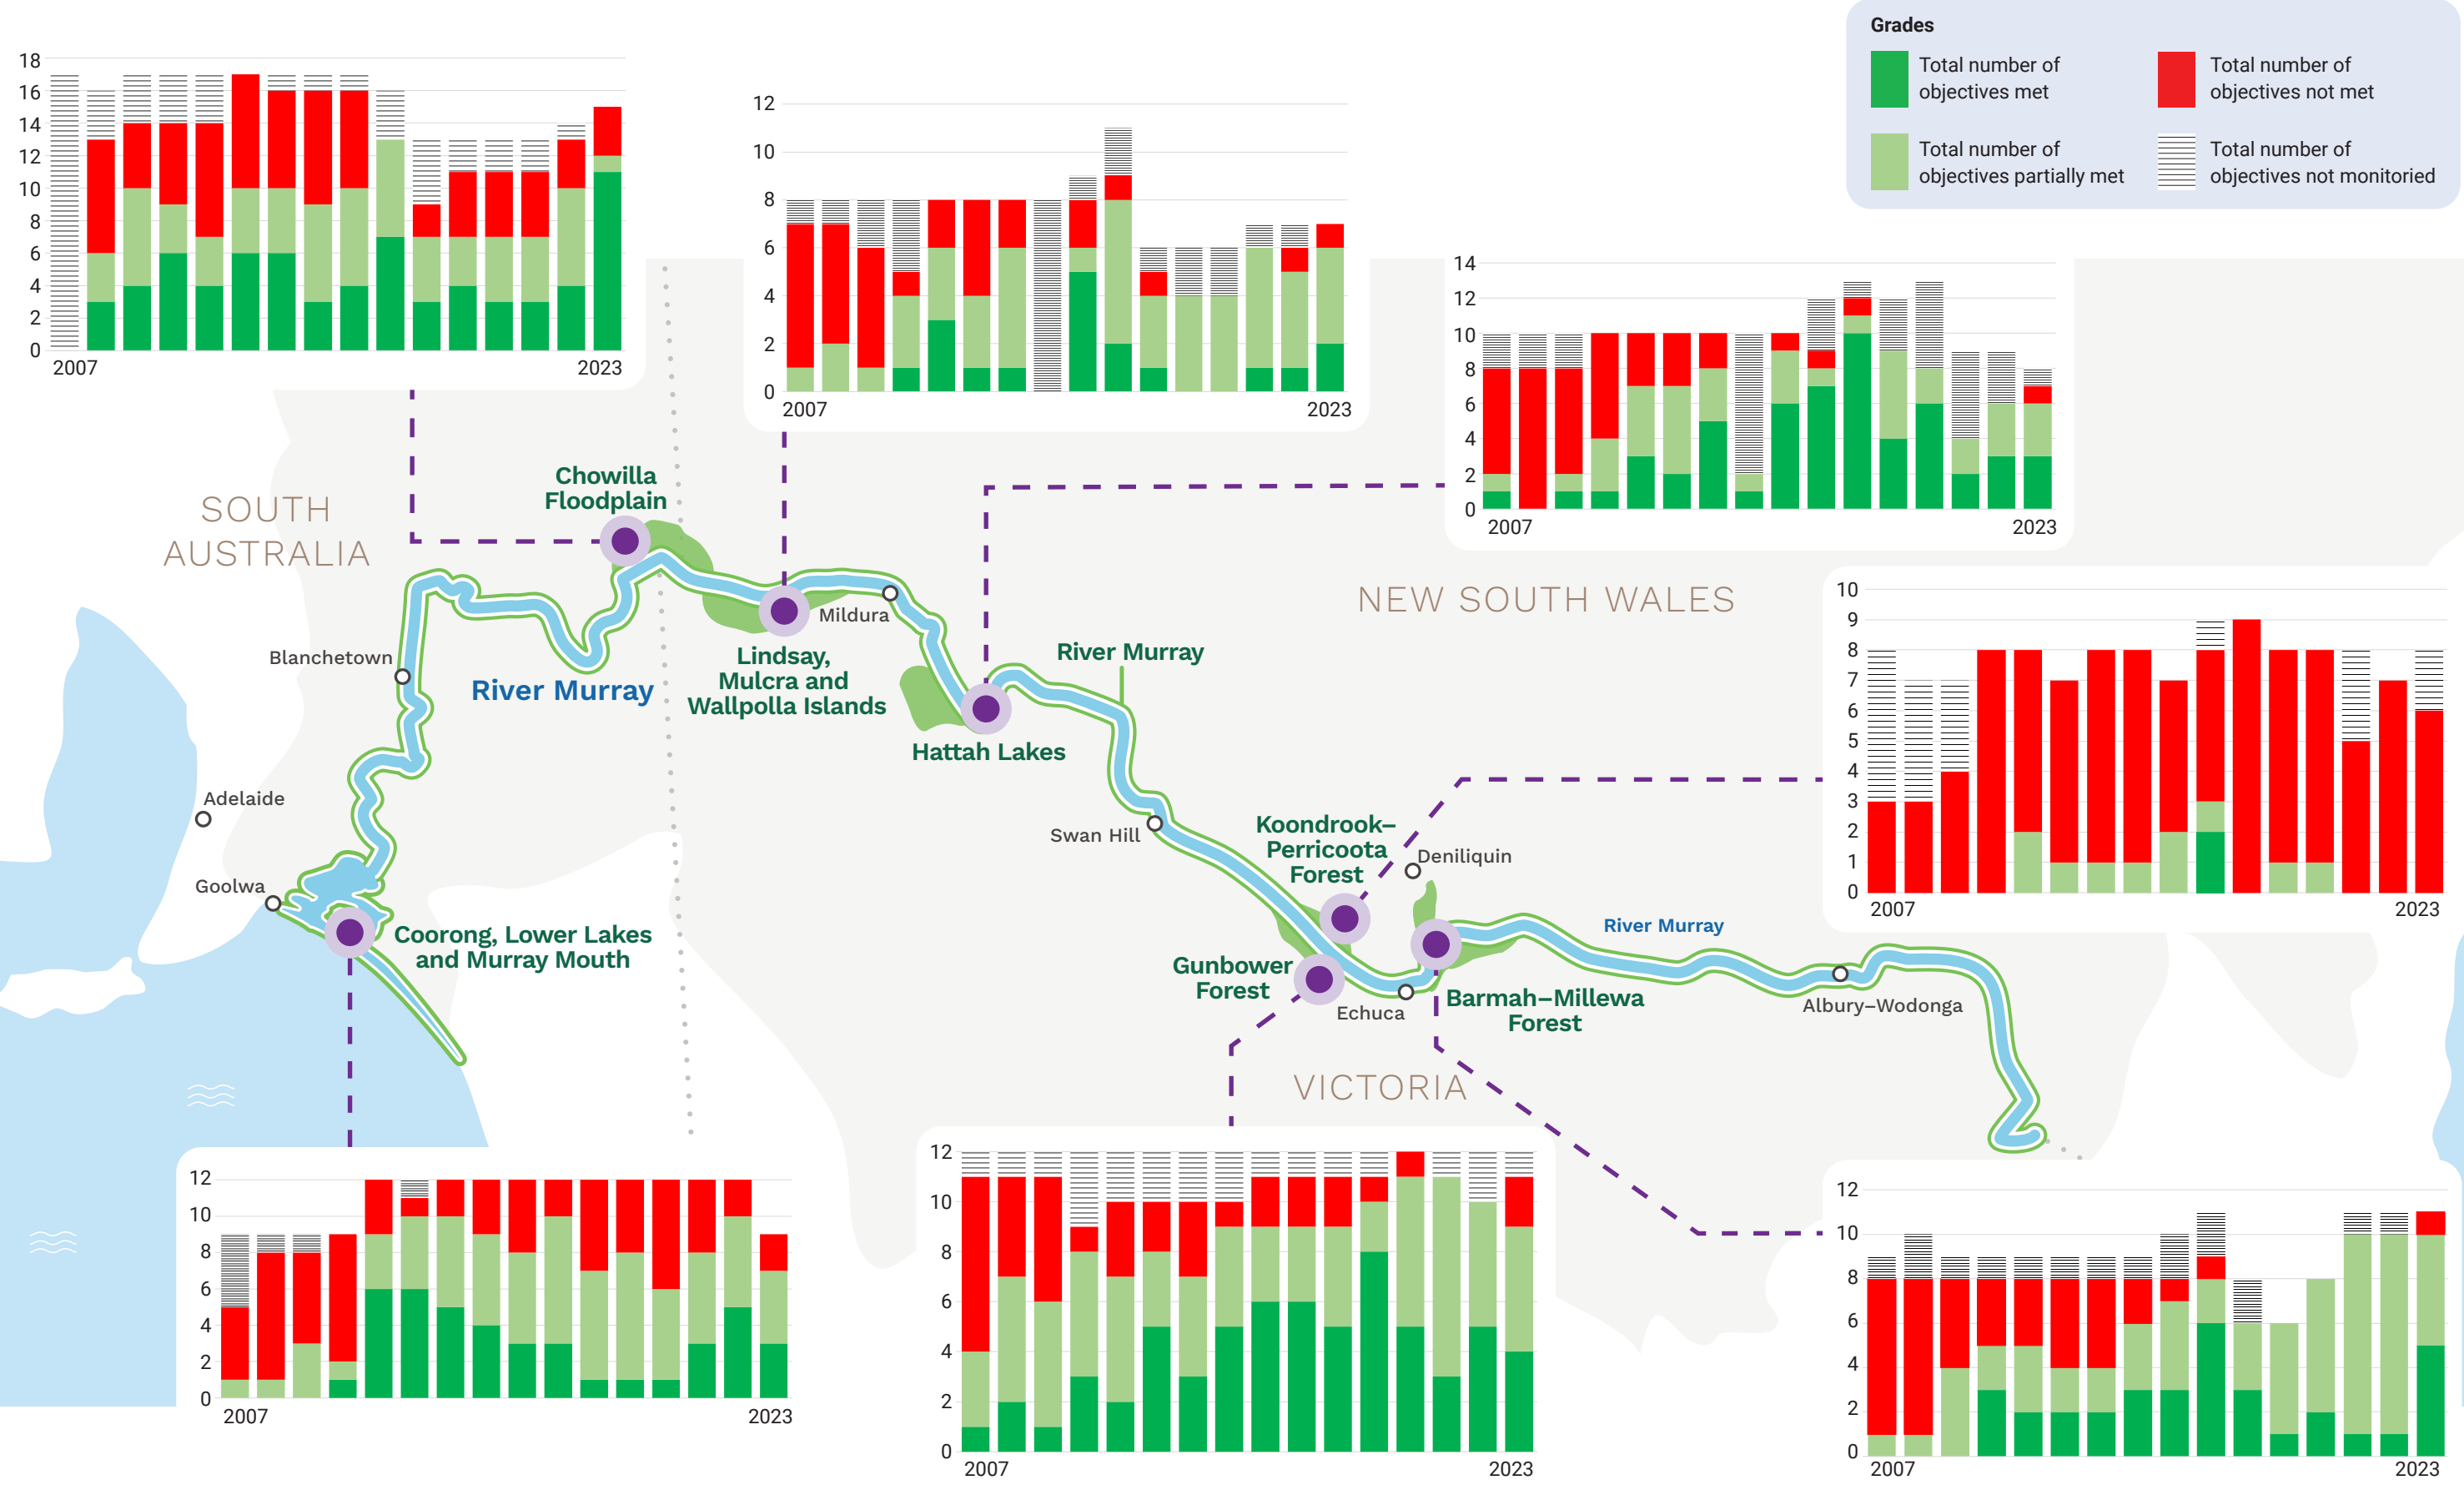
Ecological objectives over time

Yearly monitoring has taken place at all icon sites since 2006-2007 to assess the relative condition of each site through measuring a series of environmental objectives. Objectives can be met, partially met or not met and this is tracked over time for vegetation, fish, waterbirds and other environmental functions. The ecological objectives vary between each of the icon sites.
