# Options for Managing Sediment in the Barmah-Millewa Reach of the River Murray

## Preliminary Investigations

*Report for Murray–Darling Basin Authority*

November 2021

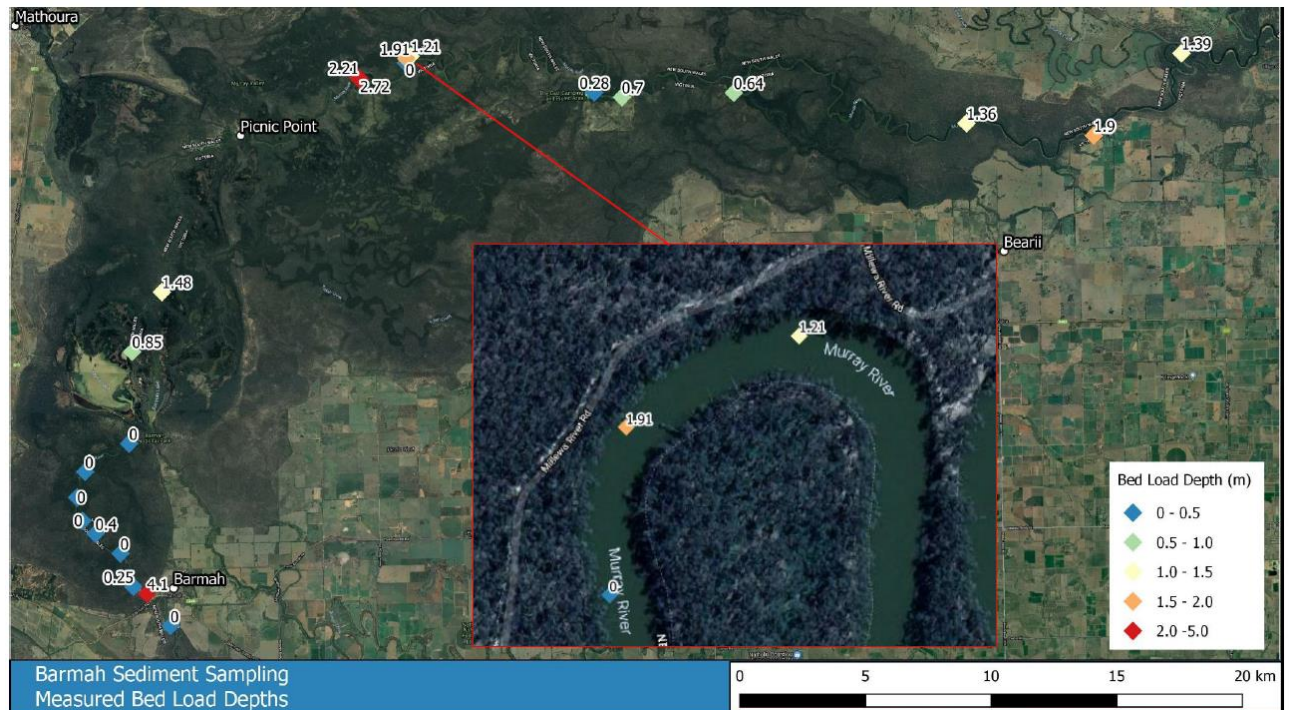
Figure 5 Bedload validation sampling locations (Water Technology, 2021)

As part of their field campaign, (Water Technology, 2021) undertook a field validation of the sub-bottom profile dataset by measuring the depth of sediment at selected locations in the field. The bedload depth validation locations were selected as areas that the sub bottom-profiling identified as having consistent bedload thickness across a reasonably large area. This was considered important, as the bedload measurements were taken from a boat on a flowing river, and it was not possible to accurately pinpoint identified validation points. The validation points also targeted a range of bedload thicknesses. Sampling locations and depth of bedload are shown in Figure 5.

Overall, the results of the validation were mixed with some locations showing good agreement between the two approaches, while at other locations there were discrepancies. This variability is expected given the challenges of undertaking these measurements in the field and the spatial and temporal variability of bedload thickness across and along the channel. Further field validation measurements of the bedload thickness and rate of movement are recommended during the next stages of the options assessment process.

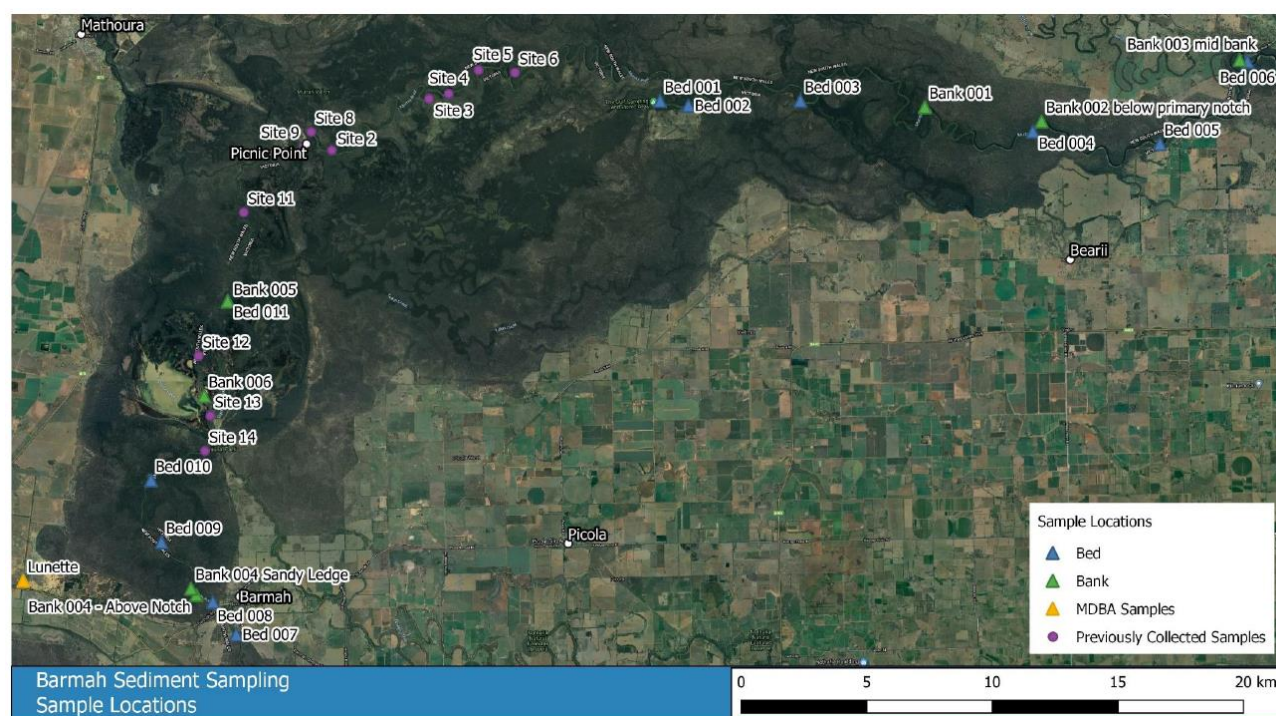
Figure 6 Bed and Bank Sediment Sampling Locations (Water Technology, 2021)

The location of the bed and bank samples is provided in Figure 6. Additional upstream sites on in-channel point bars at Tocumwal Beach and Thompsons Beach at Kennedy Park in Cobram are not shown.

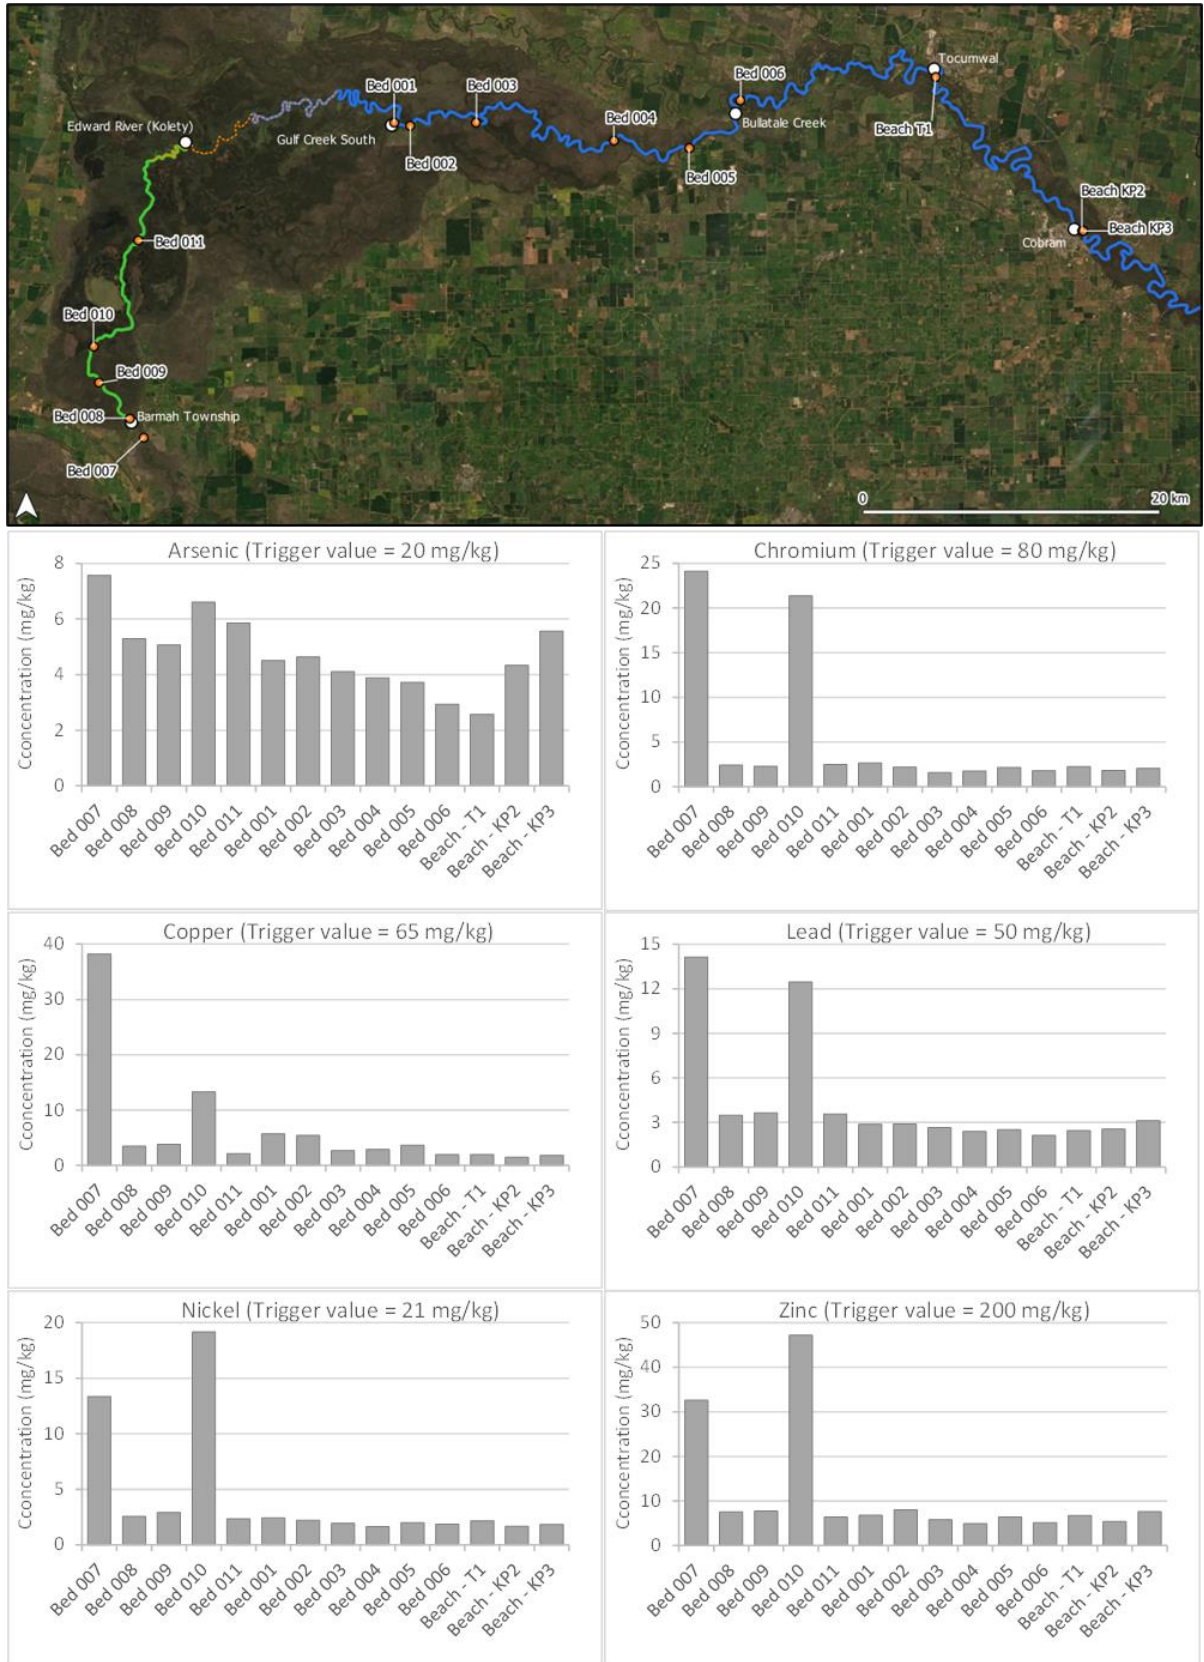
Figure 8. Map of sediment sample locations (top) and plots of heavy metal concentrations in samples from 14 locations along the River Murray, between Cobram and Barmah township.

The results for six metals (arsenic, chromium, copper, lead, nickel, and zinc) are plotted in order from downstream to upstream in Figure 8. There is a very slight trend of increasing concentrations downstream (although still well below threshold values), which is likely reflective of the increasing proportion of finer sediment in the samples in the downstream direction. The highest concentrations for all six metals were found in sample Bed 007, just downstream of Barmah township, and Bed 010, downstream of the Barmah lakes.

All metal concentrations for all samples were below the threshold limits.

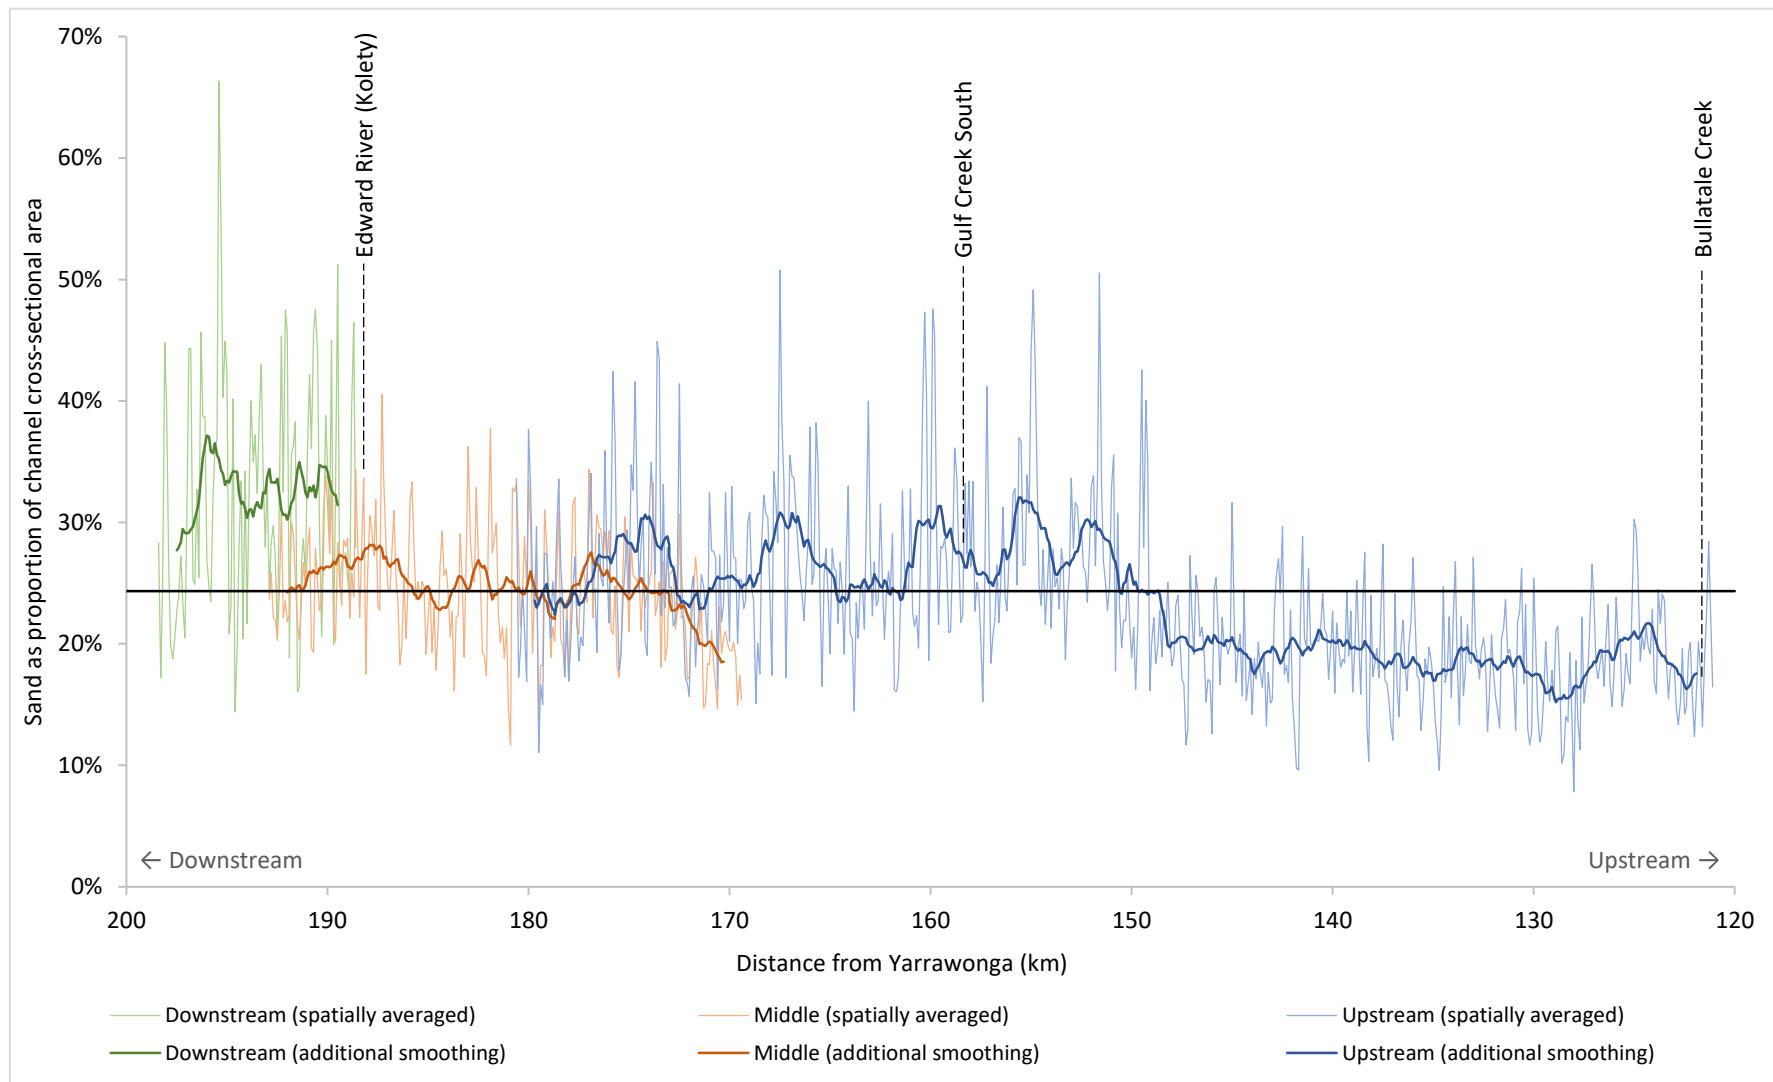
Figure 11. Plot of average bedload thickness as a proportion of channel cross-sectional area for the 80 km reach downstream of Bullatale Creek. Pale lines represent raw thickness data that has been spatially average using overlapping buffers every 100 m (see Figure 9). Dark lines are the result of additional linear smoothing using a 1.8 km moving average. Black line is the overall mean for the complete dataset.

- For the 180 km of the Barmah-Millewa reach for which channel dimensions are available, bedload sand reduces the total channel capacity by an average of 24 % overall.
- Because channel dimensions decline progressively downstream, the same thickness of bed material occupies proportionally more of the channel cross section downstream versus upstream.
- For the first 30 km of the Barmah-Millewa reach (120 – 150 km) the reduction in capacity caused by bedload is approximately 20 %.
- From the 150 km mark downstream to the Edward River (~190 km mark) the reduction in capacity averages 25 – 30 %.
- Downstream of the Edward River, 30 – 35 % of the channel is occupied by bedload sand.

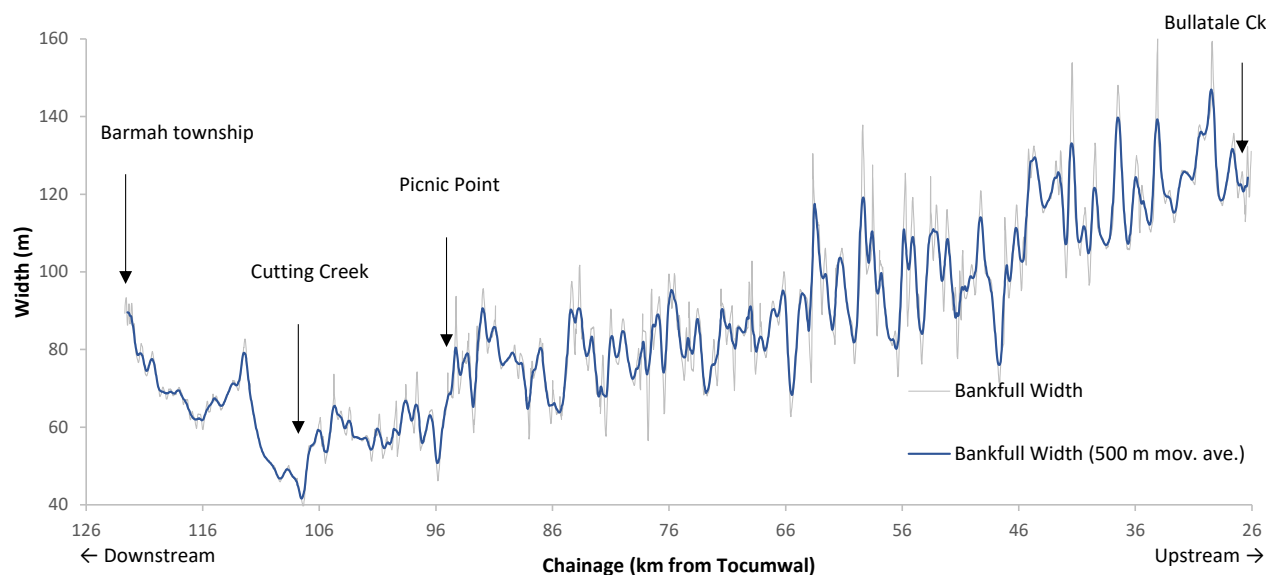
Figure 12 Plot of the River Murray bankfull width from Bullatale Creek to Barmah township (Streamology, 2020)

- The combination of the declining width and depth compounds to substantially reduce the cross-sectional area through the reach. From a peak cross-sectional area of about 1,000 m<sup>2</sup> at 34 km downstream of Tocumwal, area declines to a minimum of 250 m<sup>2</sup> at the 94 km mark, 10 km downstream of Picnic Point (Figure 13). This decrease represents a 75 % reduction in cross-sectional area which will translate into corresponding decreased flow conveyance, depending on channel slope and roughness.

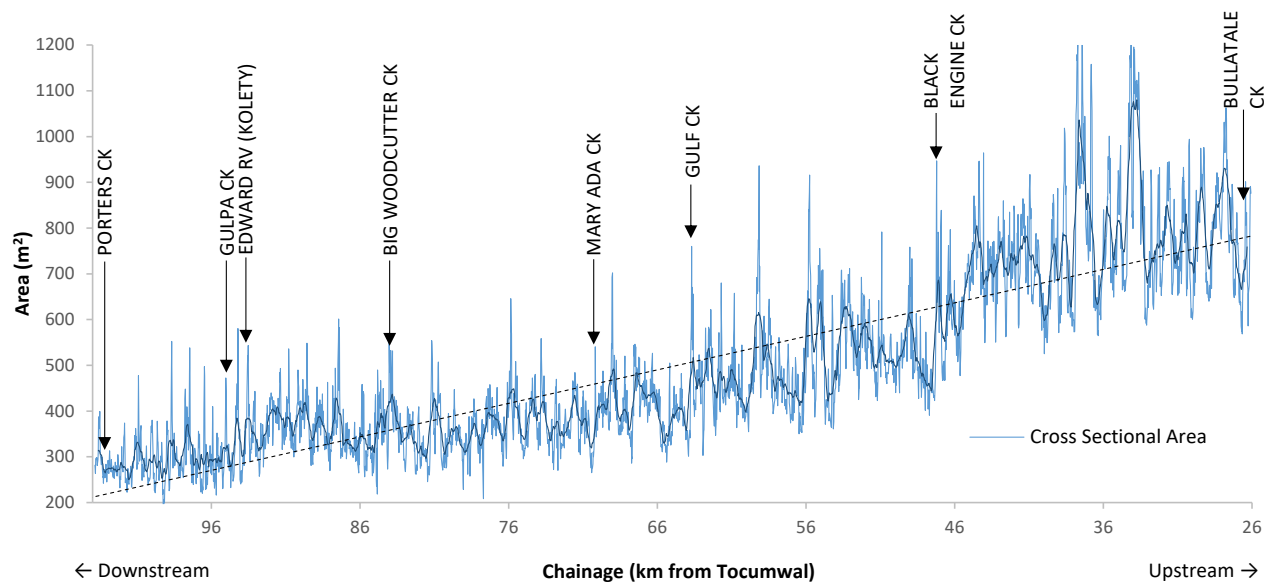
**Figure 13 Plot of River Murray cross-sectional areas from Bullatale Creek to Porters Creek**

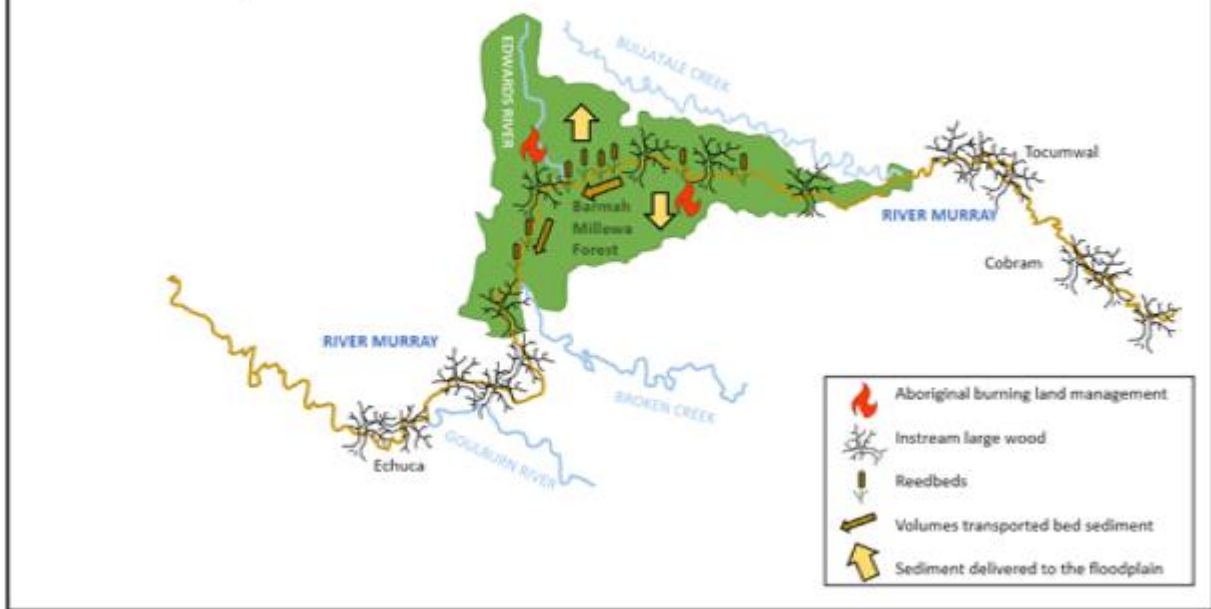
Figure 24. The pre-European reference condition of the River Murray and Barmah-Millewa Forest. The River Murray is brown to signify that it conveyed sediment, and the width of the line and arrows indicate relative volumes of sediment, the lighter colour being mainly suspended sediment. Snags were present in the channel, rushes were more extensive, sediment volumes into the reach were low and proportionally higher in suspended sediment with high losses onto the floodplain, land management was Aboriginal burning.

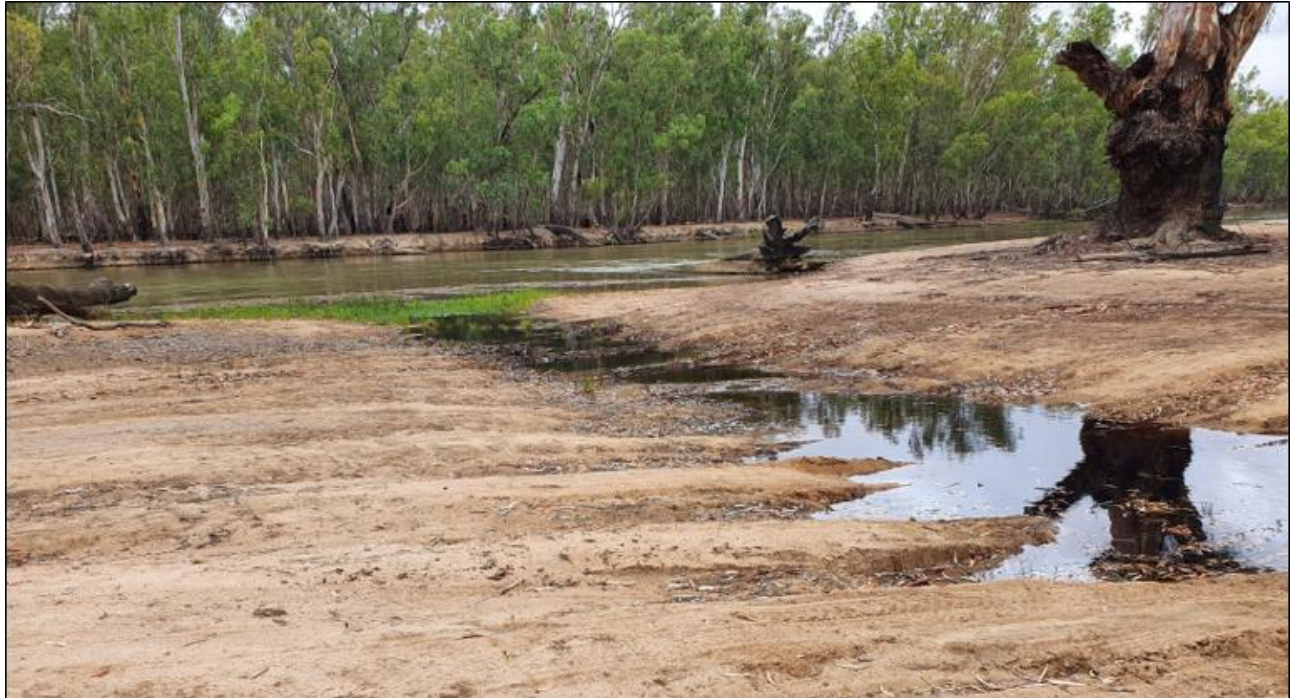
Figure 29 Example of a site in the Barmah-Millewa reach where flows into the adjacent forest along an effluent channel are increasing under regulated conditions. Image was captured by Professor Ian Rutherford in 2021.

A breakaway developing from the main river channel is shown in Figure 29.

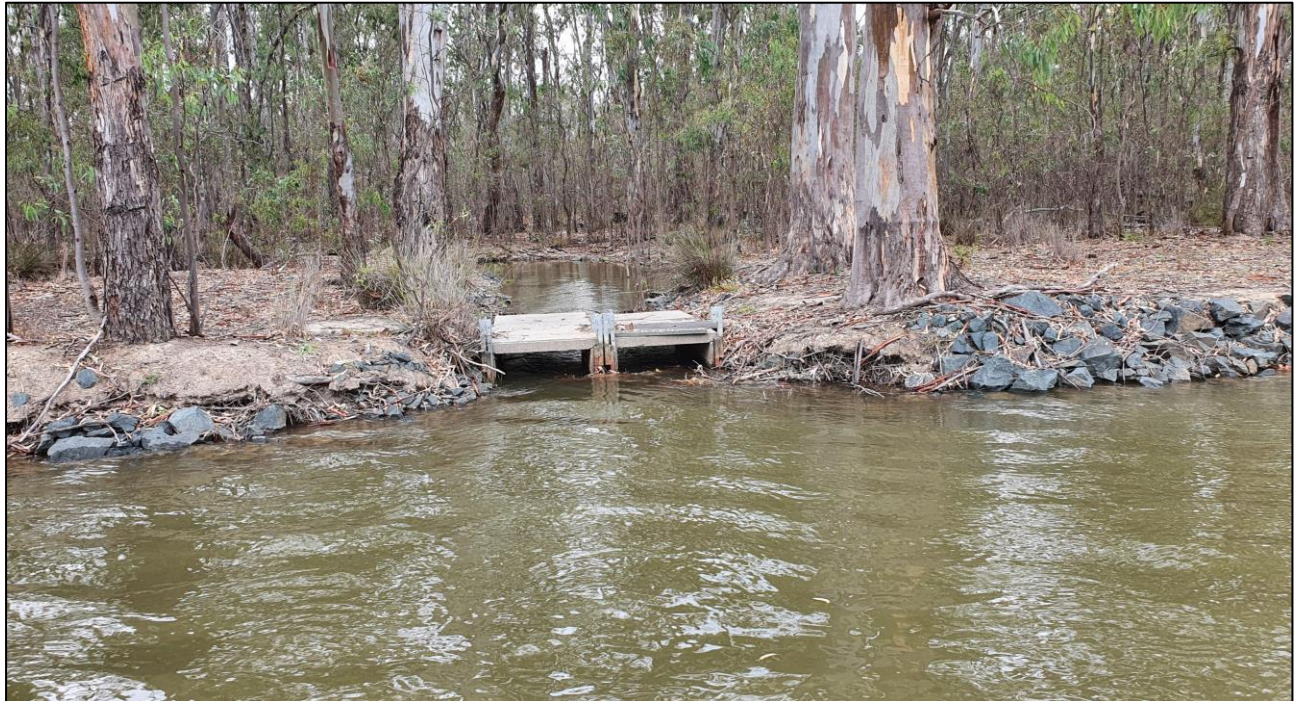
Figure 31 Example of existing bank protection works at a small regulating structure on the Barmah-Millewa reach upstream of the Edward River confluence. Image was captured by Professor Ian Rutherford in 2021.

To manage the increasing erosion of the riverbanks and enhanced unseasonal loss of water through activation of new or enlarged existing effluents, a program of bank protection works will be required. Examples of existing bank protection works along this reach are provided in Figure 31 and Figure 32.

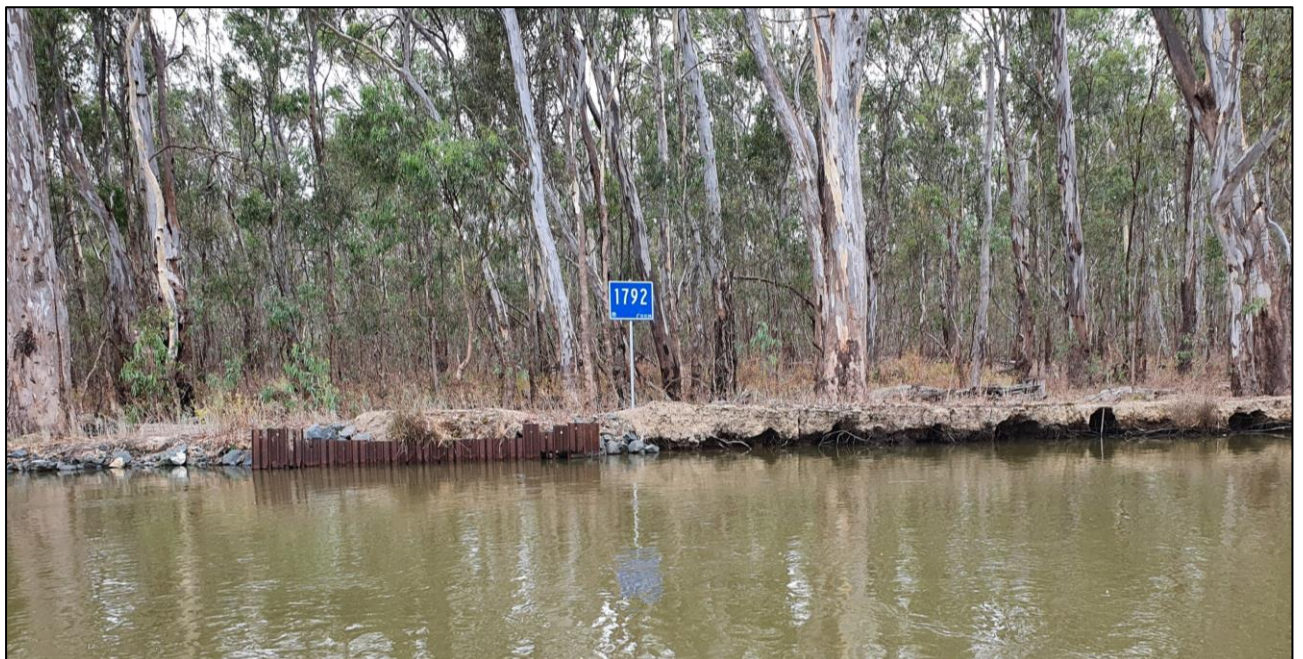
Figure 32 Example of existing bank protection works (sheet piling) on the Barmah-Millewa reach upstream of the Edward River confluence. Image was captured by Professor Ian Rutherford in 2021.

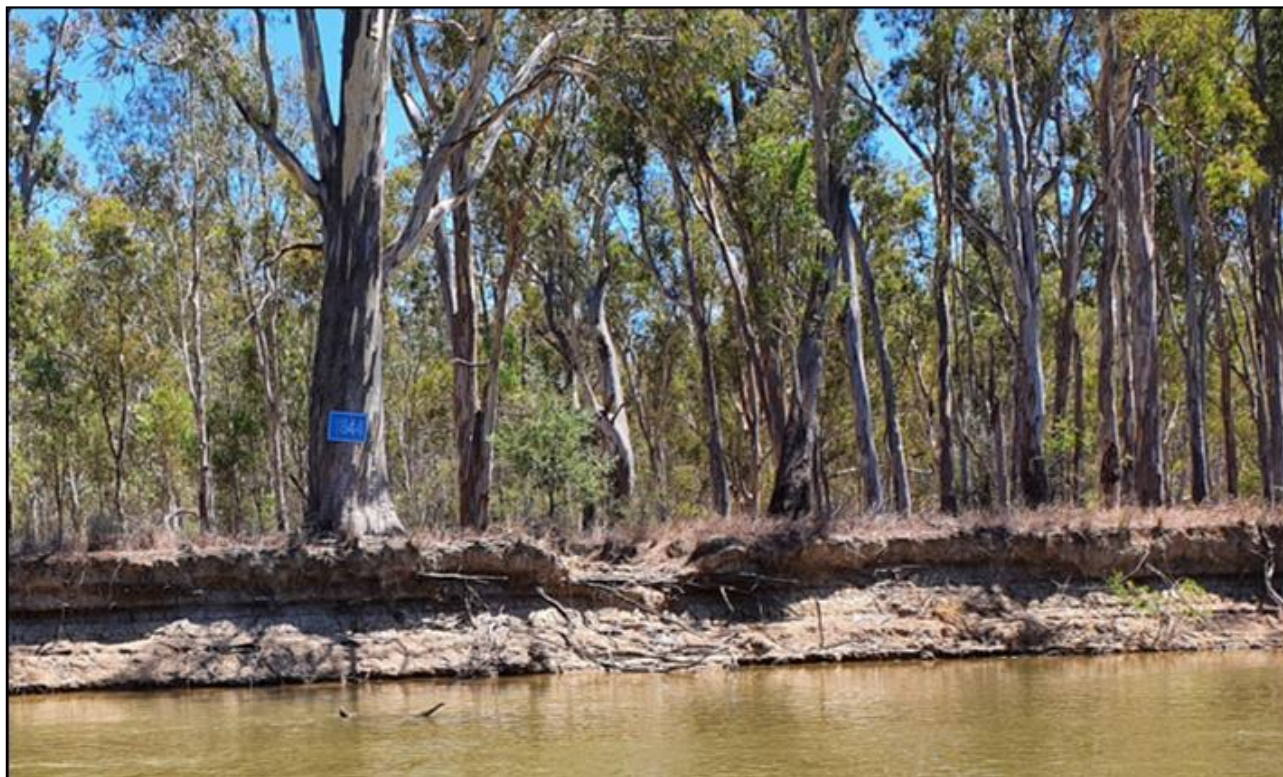
Figure 33 Example of an effluent channel which could become more regularly connected to the river if regulated water levels are increased. Image was captured by Professor Ian Rutherford in 2021.

An effluent channel that could become more actively engaged under higher regulated flow condition is shown in Figure 33 and Figure 34.

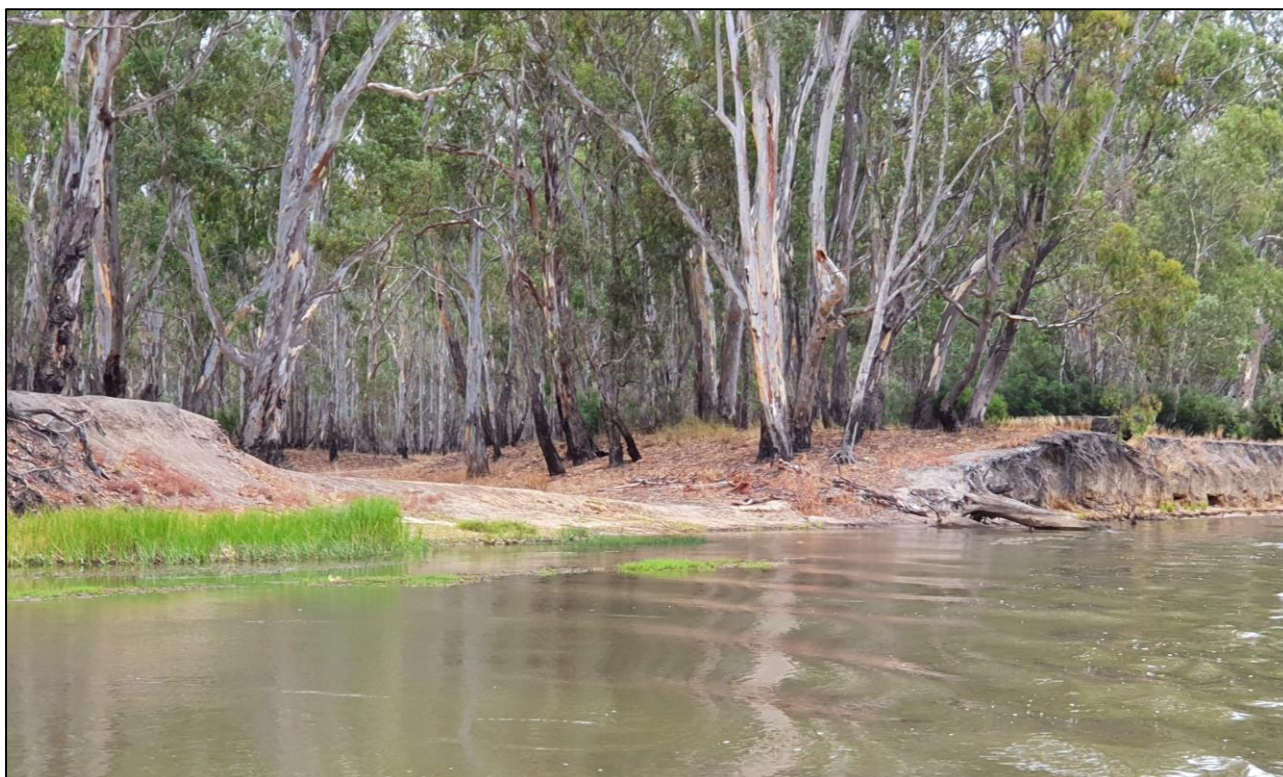
Figure 34 Another example of an effluent channel which could become more regularly connected to the river if regulated water levels are increased. Image was captured by Professor Ian Rutherford in 2021.
