A fluvial geomorphic investigation into channel capacity changes at the Barmah Choke using multiple lines of evidence

The Murray–Darling Basin Authority

Dr. James R. Grove

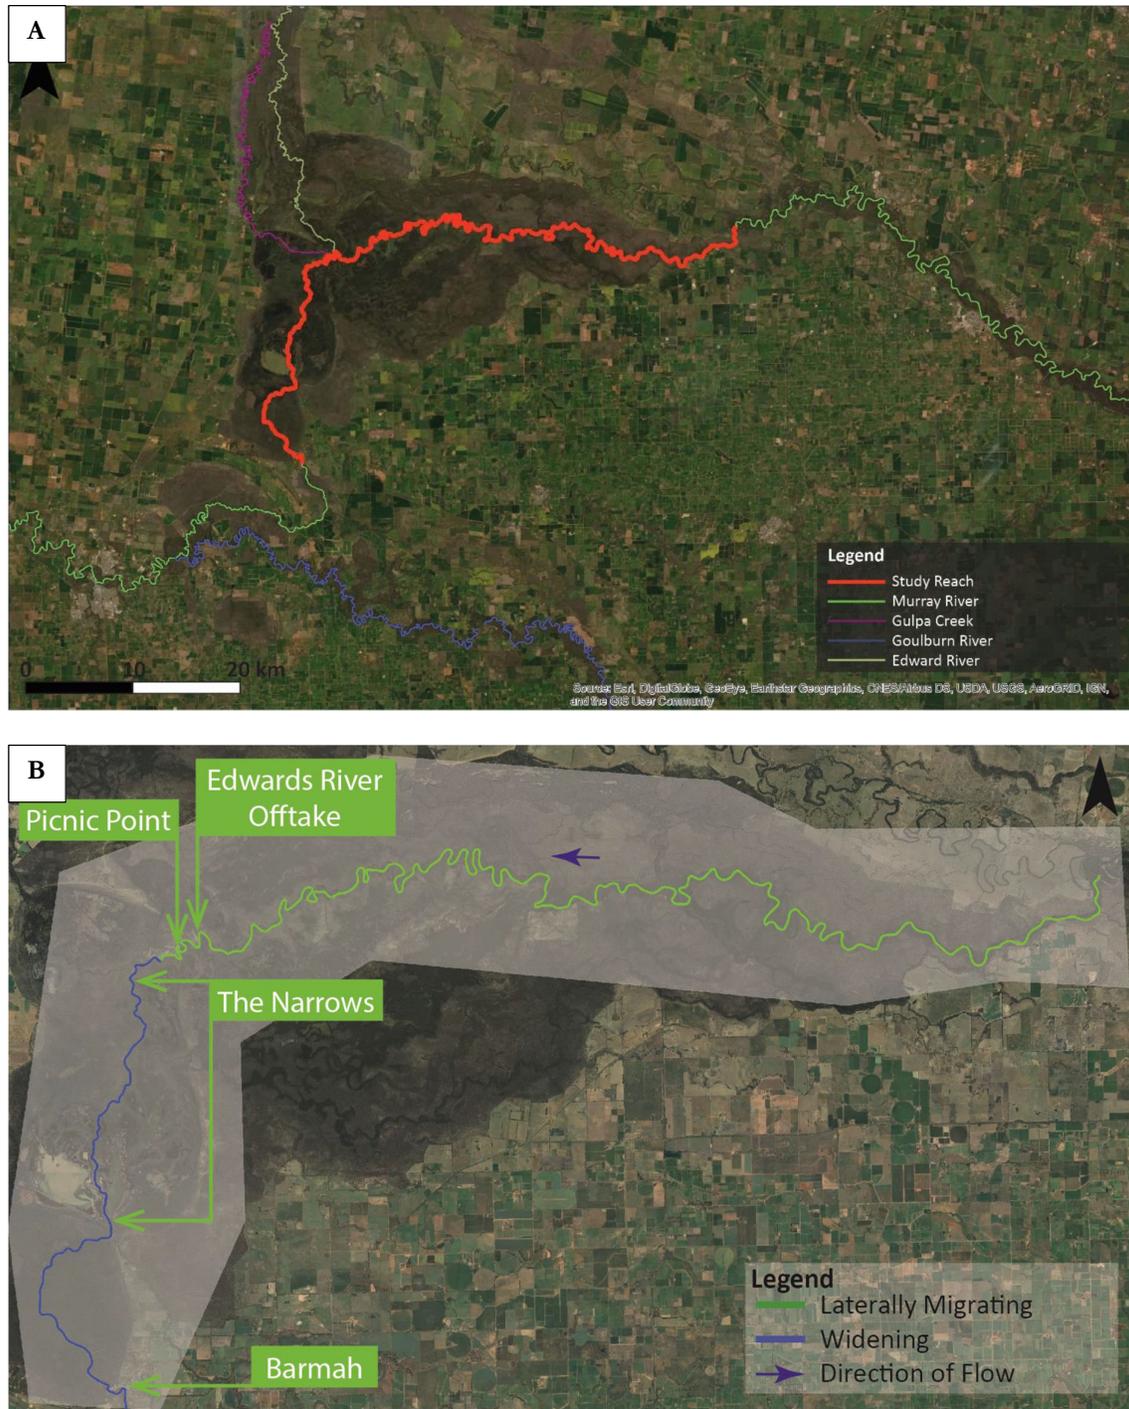
Figure 1-3. A) The reach extent used by Water Technology (2020) to investigate channel changes, B) the dominant process zones identified in the reach by Water Technology (2020).

Between Corowa and Bullatale Creek the river is relatively wide set in a narrow floodplain of around 3 km in width. The meandering channel has distinctive and extensive sandy point bars. Further downstream, Tuppall and Bullatale Creeks are large effluent channels that take water from the River Murray and deliver it to the Edward-Wakool system (**Figure 1-3**).

1. Bankfull channel widths have slightly increased in the section of the Choke known as ‘The Narrows’ (**Figure 1-3B**) from 2001-2016.
2. The channel bed elevation appears to have stayed the same in The Narrows meaning the channel cross-sectional area is probably not decreasing.
3. Bankfull channel widths in the upper reach, at the upstream end of the Barmah-Millewa Forest (**Figure 1-3**) have not changed significantly from 2001-2016.
4. The hydraulic conveyance loss is likely to be the result of the erosion and breaching of levee features, resulting in increased water losses in the forest.

The previous work by Water Technology (2020) used a reach extent from the offtake of Bullatale Creek to Barmah (**Figure 1-3**). This reach was 100 km in length and extended over the area covered by the Barmah-Millewa Forest and by the river bathymetry, except for the most downstream 10 km. Gippel and Lucas (2002) used a reach that extended from just downstream of Yarrawonga Weir (at river chainage 1987) to Echuca (at river chainage 1706). This 281 km reach allowed comparisons with historic surveys.

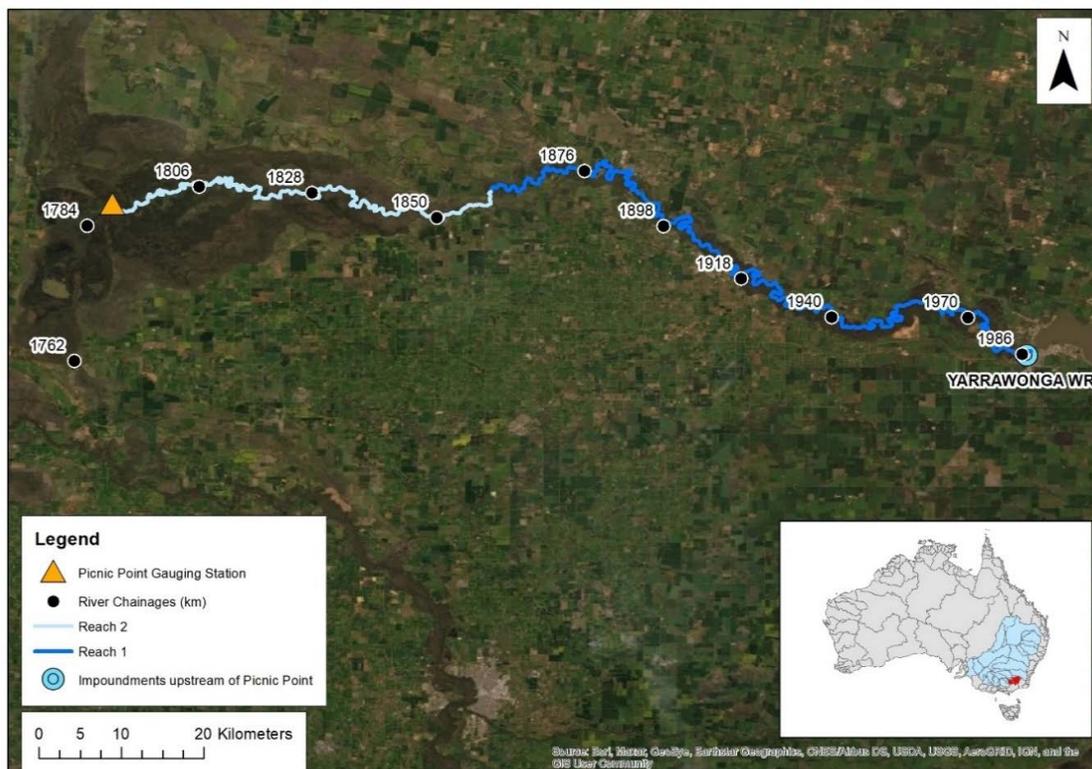
Figure 3-4. A map of Reaches 1 and 2 showing MDBA river chainages.

- Reach 1: Yarrawonga Weir to just upstream of Bullatale Creek (119 km).
- Reach 2: Bullatale Creek to Picnic Point (68 km).

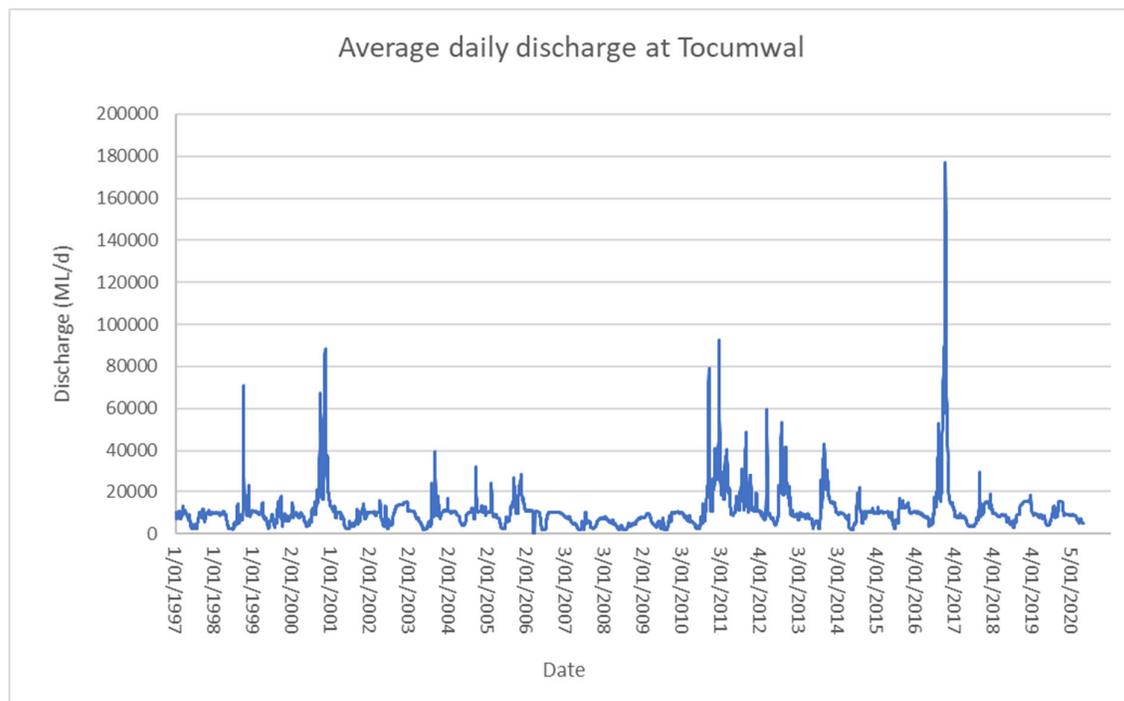
Figure 5-2. Average daily discharge at Tocumwal from 01/12/1996 to 18/06/2020.

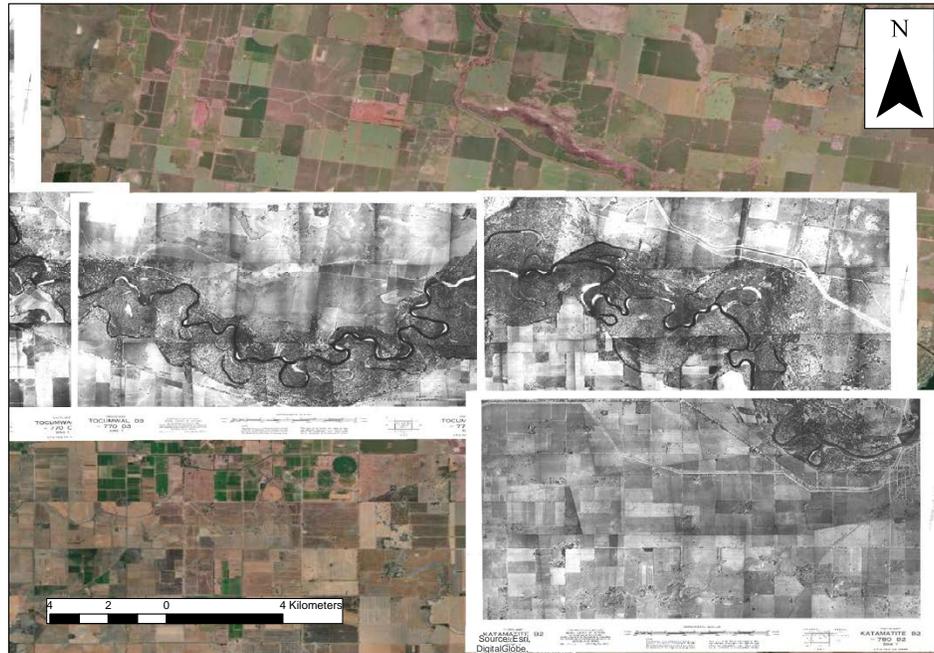
Figure 6-2. 1949-1950 aerial photos of the River Murray directly downstream of Yarrawonga Weir.

It does appear as if there was more sediment in the channel and on the point bars downstream of this zone of potential erosion. It is difficult to determine the extent of depositional features because surface reflectance on the water is similar in colour to sand deposits (**Figure 6-2**). The region around 8-40 km downstream of Yarrowonga Weir appears to have more sandy material in 1945-1950 than currently (**Figure 6-3**). Without other measurements it is difficult to interpret what this may mean for the transport of sand in this section. It could suggest this might have been a region of enhanced deposition of upstream erosion or it could mean increased transport of sediment on the bars from more rapid lateral migration.

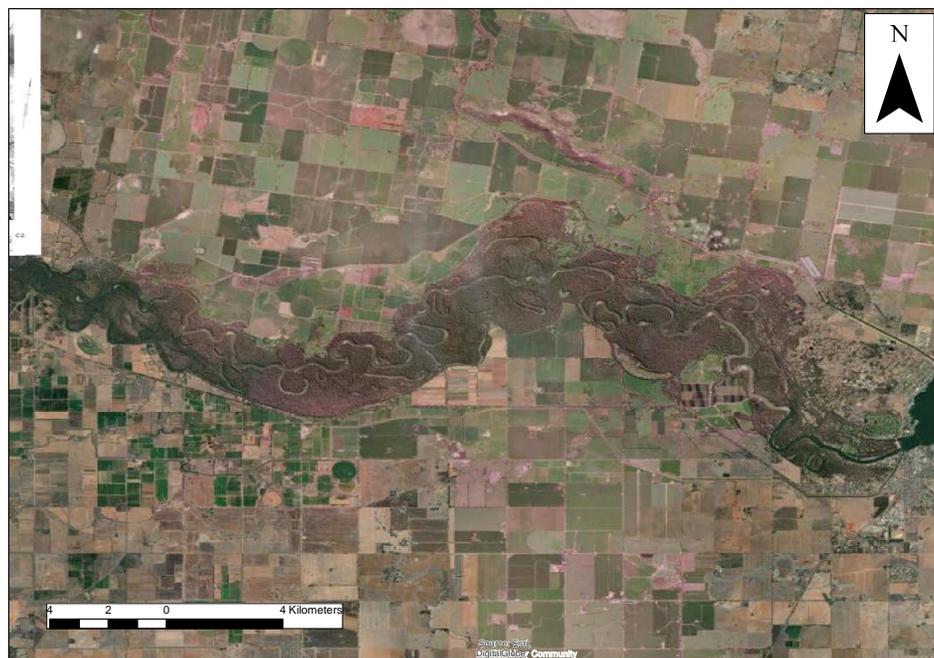
Figure 6-3. Current imagery from ArcGIS directly downstream of Yarrawonga Weir.

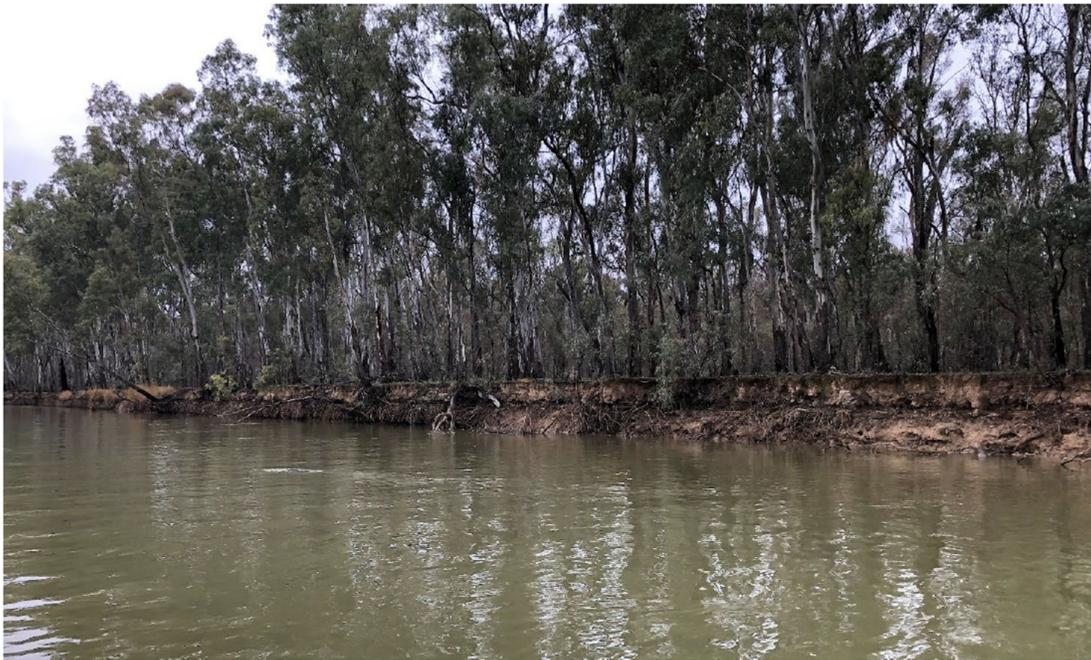
Figure 6-10. Vertical bank faces that Water Technology (2020) consider typical of boat wash induced erosion. The notch halfway up the bank is at the elevation of a regulated release of 9,000 ML/d from Yarrowonga Weir in the summer (Photo from Water Technology 2020).

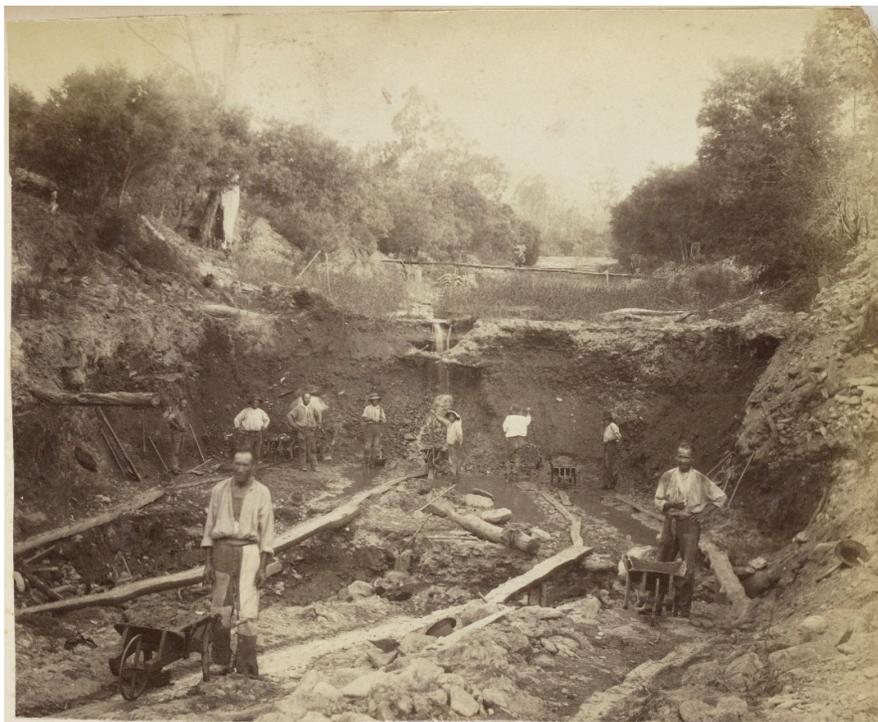
Figure 7-7. Mining for gold in the bed of a river in the vicinity of Beechworth, unknown date (courtesy of the State Library of Victoria).

The number of miners (**Figure 7-6**) operating this relatively small-scale processing system was so large that it provided an enormous sediment supply directly into the stream (**Figure 7-7**). Coarse sediment, such as cobbles and boulders were removed from the sediment and stacked locally. These stacks were often within the flood extent area and could be moved during high flow events. The sediment processed in the boxes was a range of sizes and so would enter the river as bed, suspended and wash loads.

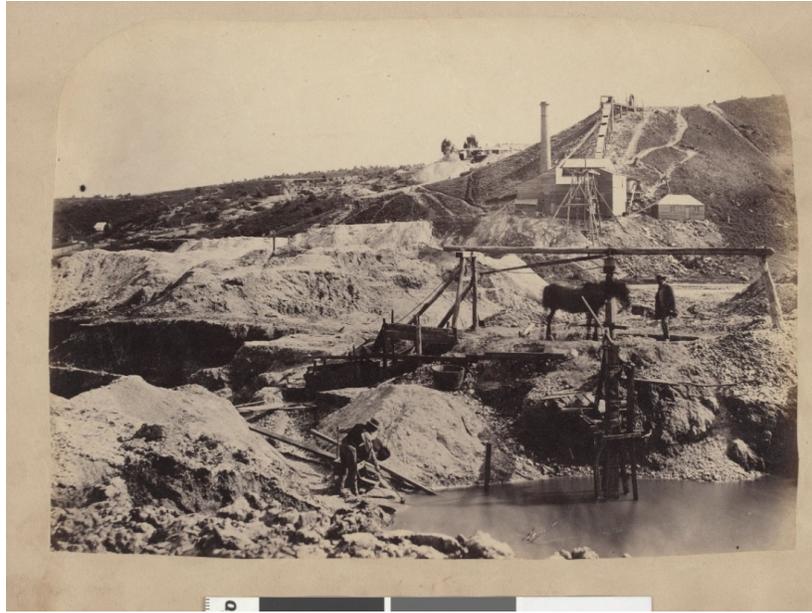
Figure 7-9. Looking across earth works with miners using a gold washing cradle in the foreground, man standing beside horse-drawn whim and crushing battery with conveyor in background. Photograph taken between 1854 and 1862 (courtesy of the State Library of Victoria).

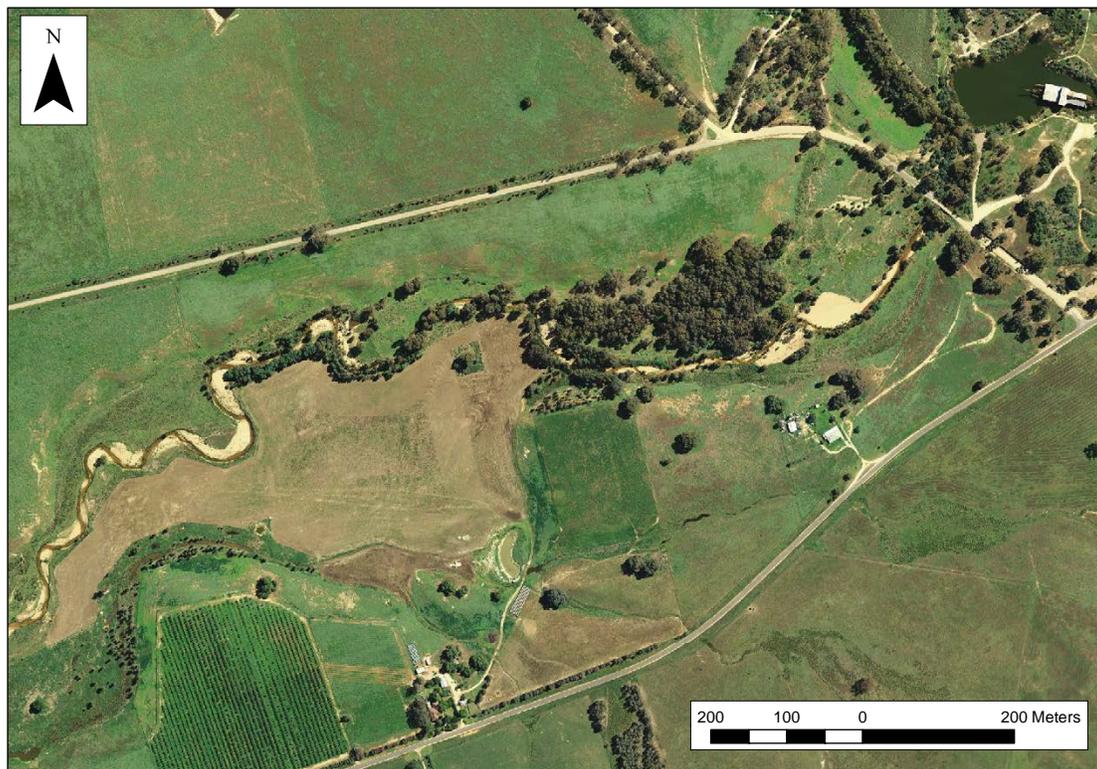
Figure 7-14. A 2010 aerial photograph of the Reedy Creek, a tributary of the Ovens River. The Eldorado dredge is floating in a dredge pond in the top right of the image. Flow is from right to left of the figure.

Anecdotal evidence suggests that subsequent redeposition may have occurred in channels that had started to incise, and once the dredging ended the channels would have started to re-incise. This could have been as recently as 1955 for the Tronoh dredge in Harrietville on the Ovens River. An example of incision after a pulse of sand sized sediment downstream of dredge site can be seen at Eldorado, Victoria (**Figure 7-14**) The dredge operated from 1936 to 1954 and has resulted in high loads of sand sized sediment both in the channel and on the floodplain of Reedy Creek. The sand pulse is now migrating downstream towards the Ovens River.

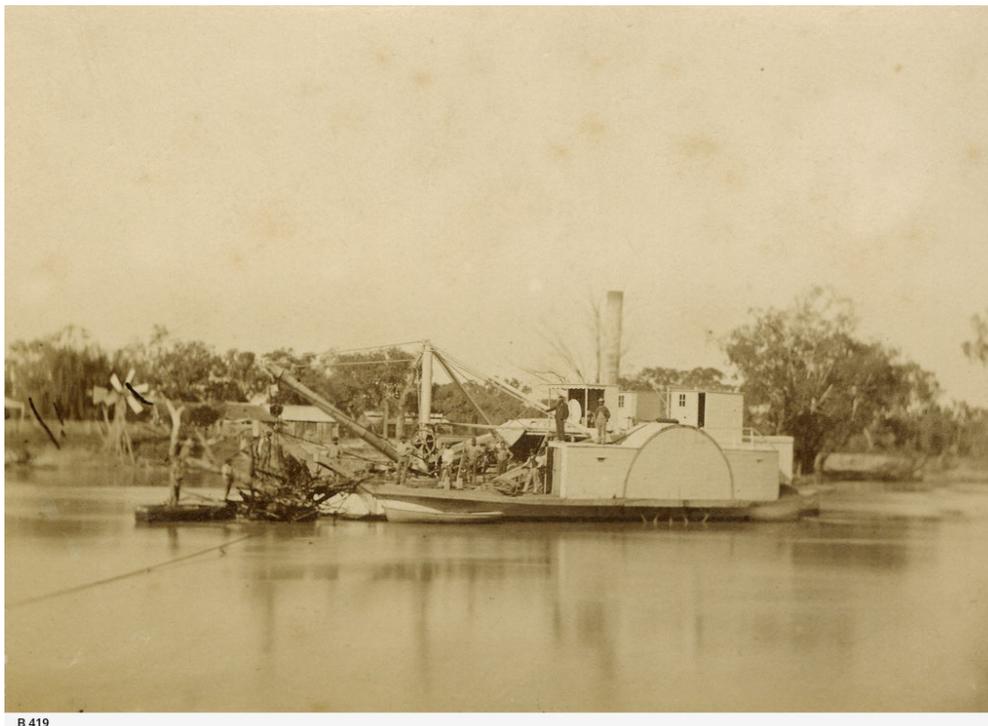
Figure 8-1. Side view of 'P.S. Grappler' at work snagging, removing fallen trees and obstructions from the river. Built at Echuca, 1858. Launched on the 1.2.1858. Government owned boat for snagging. From 1878 was used as a police station at North West Bend, Morgan. Converted to a dredge in 1880. (Godson number 9A/34). (Courtesy of the State Library of South Australia).

Hodgkinson (1856, p.10) indicates that the River Murray Navigation Company had been given money to desnag around Barnawartha and Wahgunyah. A combination of approaches was initially used. The depth of draft needed for a loaded barge was 2 ft 9 inches or 0.84 m. Logs were cut at low water in the channel, and Captain Cadel also used the Grappler (**Figure 8-1**) to lift large wood out of onto the channel banks.
