MURRAY-DARLING BASIN AUTHORITY
Lake Victoria Annual Report 2010-11

STATEMENT OF THE STATUS OF CULTURAL HERITAGE AT LAKE VICTORIA

Reporting period 2010–11

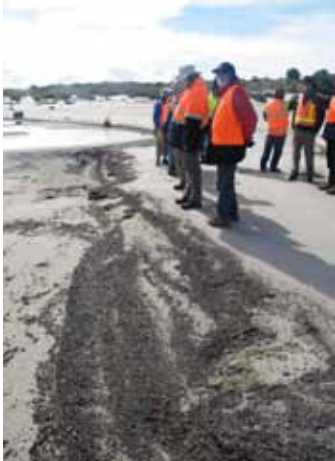
<p>SRP assesses shoreline change. Photo courtesy of Lyn Barnes</p>	<p><i>Vegetation and particularly the recruitment of spiny sedge</i> <i>Landscape Function Analysis</i></p> <ul style="list-style-type: none"> – A demonstration by Mr David Tongway of the 'Landscape Function Analysis' procedure which involves measurement of the structural arrangement of plants and other interrelated dynamics such as soil dynamics, which together lead to a measure of landscape resilience. • Over the reporting period the MDBA/SRP has developed objectives and project design for a planned 'HUS' mapping study to be conducted by Mr Matt Cupper later in 2011. This study will gather information about a possible relationship between cultural heritage and the 'HUS', including how the 'HUS' may interact with gullies and older soil layers elsewhere. • Dr Colin Pardoe and Dr Jane Lennon progressed development of the new 'structured cultural heritage monitoring program'. Progress included: <ul style="list-style-type: none"> – Development of the Aboriginal Cultural Information Database (A.C.I.D) as a first step (refer also to CC 29 below). • A complete survey of the shoreline in September to locate cultural objects which are to be included in the structured monitoring program, and to determine new site card areas for placement into OEH, A.H.I.M.S. database. • Dr Wayne Stephenson who is a consultant statistician was engaged by the MDBA to undertake an initial pilot data analysis of the previous ten years dataset to ascertain if a larger data analysis would provide meaningful information. • The River Murray System Operations Review (MDBA) conducted some broad spatial and temporal pattern mapping to look for meaningful patterns and relationships between lake operations and other variables. • A meeting was also held between the SRP and the MDBA operations unit to address some of the uncertainties of the operating strategy. The SRP provided a recommendation to pass lake operations through 'vulnerable' elevations ranges swiftly to reduce the chance of erosion from waves. Specifically, this would involve drawing the lake down below 24.8 m AHD to 24.3 m AHD swiftly, and then refilling quickly to resume the more stable elevation levels of >24.8 m AHD. • The SRP/MDBA requested clarification from OEH about consent requirements as part of the review process.

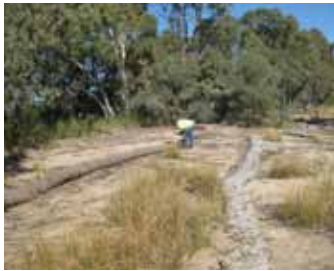
<p>Protection works on Nanya Island. Courtesy of the SA Water cultural heritage management team</p>

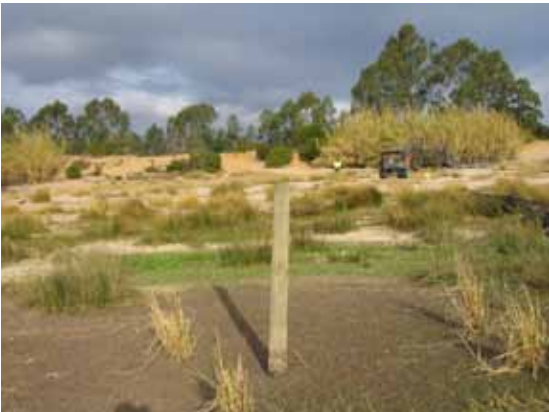
<p>Monitoring shoreline change – June 2011. Courtesy of Dr David Kennedy</p>	<p>Thirty seven transects, some established as early as 1995, are surveyed annually for the purpose of monitoring erosion and protection work performance. The majority of transects are located in areas of high cultural value. In June 2011, 34 of these transects were surveyed and compared against previous surveys to detect if significant erosion had occurred.</p> <p>The more notable results of the survey show that:</p> <ol style="list-style-type: none"> 1. No <i>significant</i> erosion has occurred in the 2010–2011 monitoring period. 2. Some erosion has occurred in historically undisturbed sediments during the 2010–11 monitoring period but not at rates considered significant. 3. Erosion was noted on profiles 28PS, 25PS, KTW, KTN, 25PS, KNU, 13PS, and 9PS. 4. It is recommended that surveys of cultural material on the above profiles should be undertaken to determine if any material is being threatened or damaged. 5. Overall profiles continue to show a mixed response to the lake operating regime and wind/wave environment, as noted in previous years.

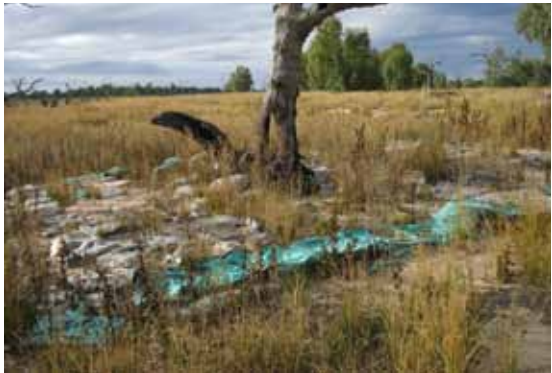
<p>Monitoring burial protection works - June 2011. Photo courtesy of Dr David Kennedy</p>	<p>Each year recommendations are a number of erosion monitoring transects cross the major burial protection works (major burial works are defined here as those works intended to retain large quantities of sand in place to provide a cover and hence protection of burials, rather than individual burial mounds) and document the performance and condition of those works. Each year recommendations are made with regard to the maintenance of those works. In 2009 and 2010 it was noted that the Snake Island wave barrier no longer functions as designed and this condition continues in 2011. Planning should begin for the repair or replacement of the wave barrier or the installation of an alternative protection measure.</p>

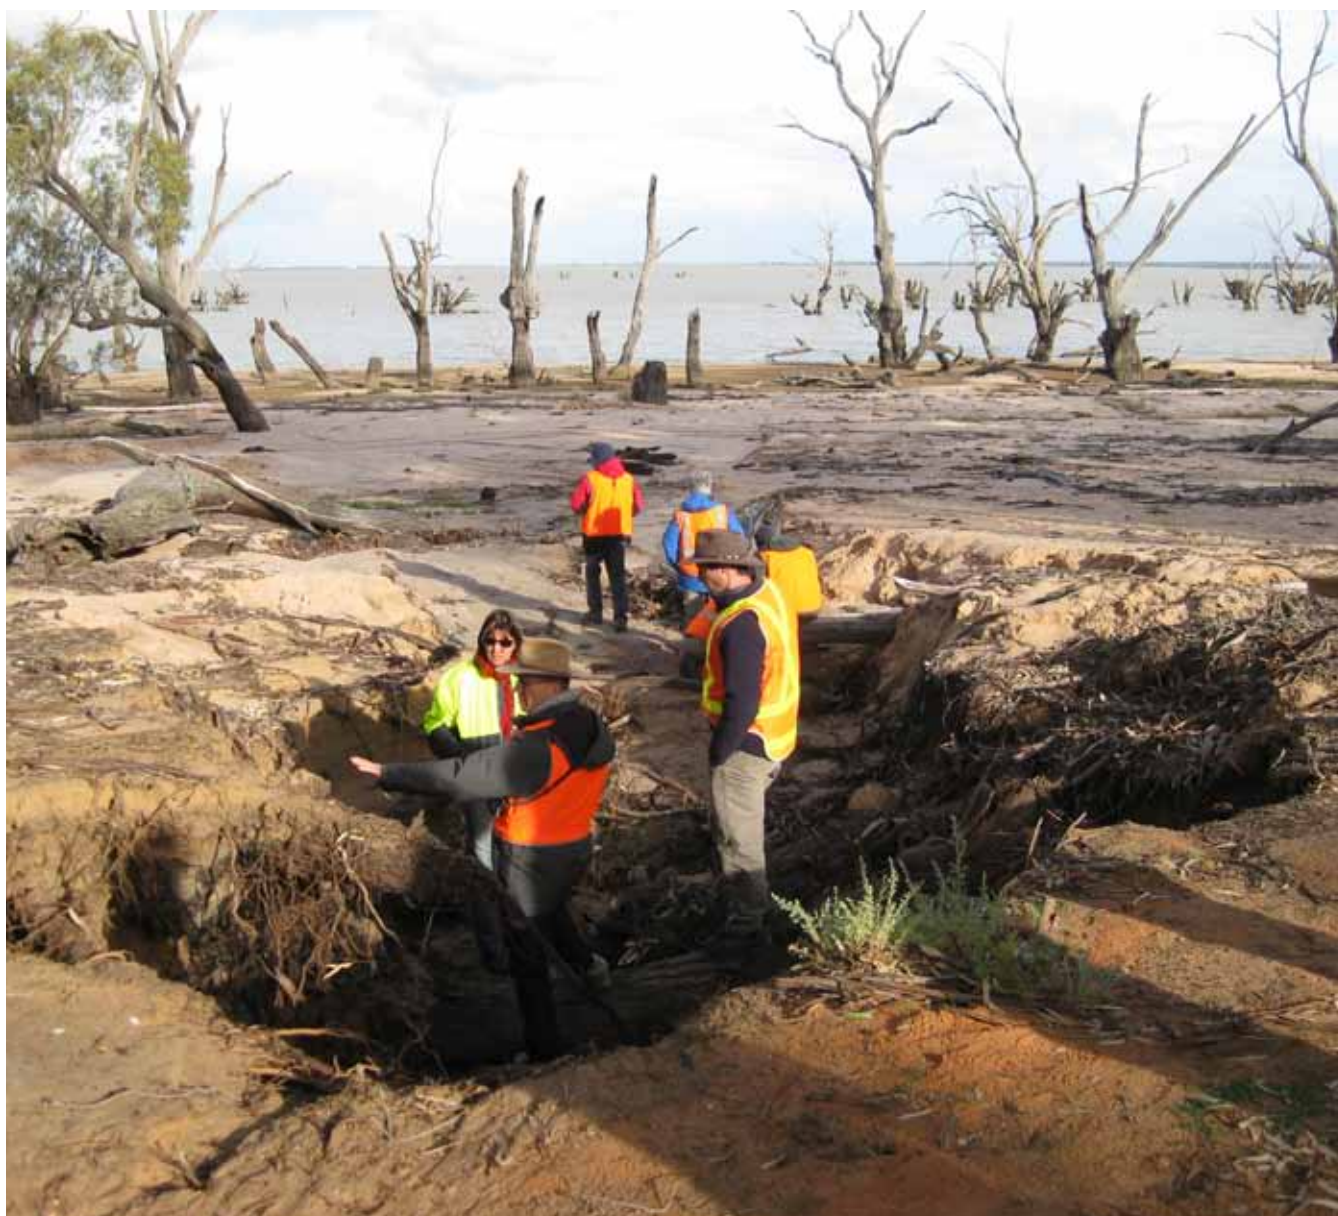
Erosion of the Noola foreshore
Courtesy of Digby Jacobs

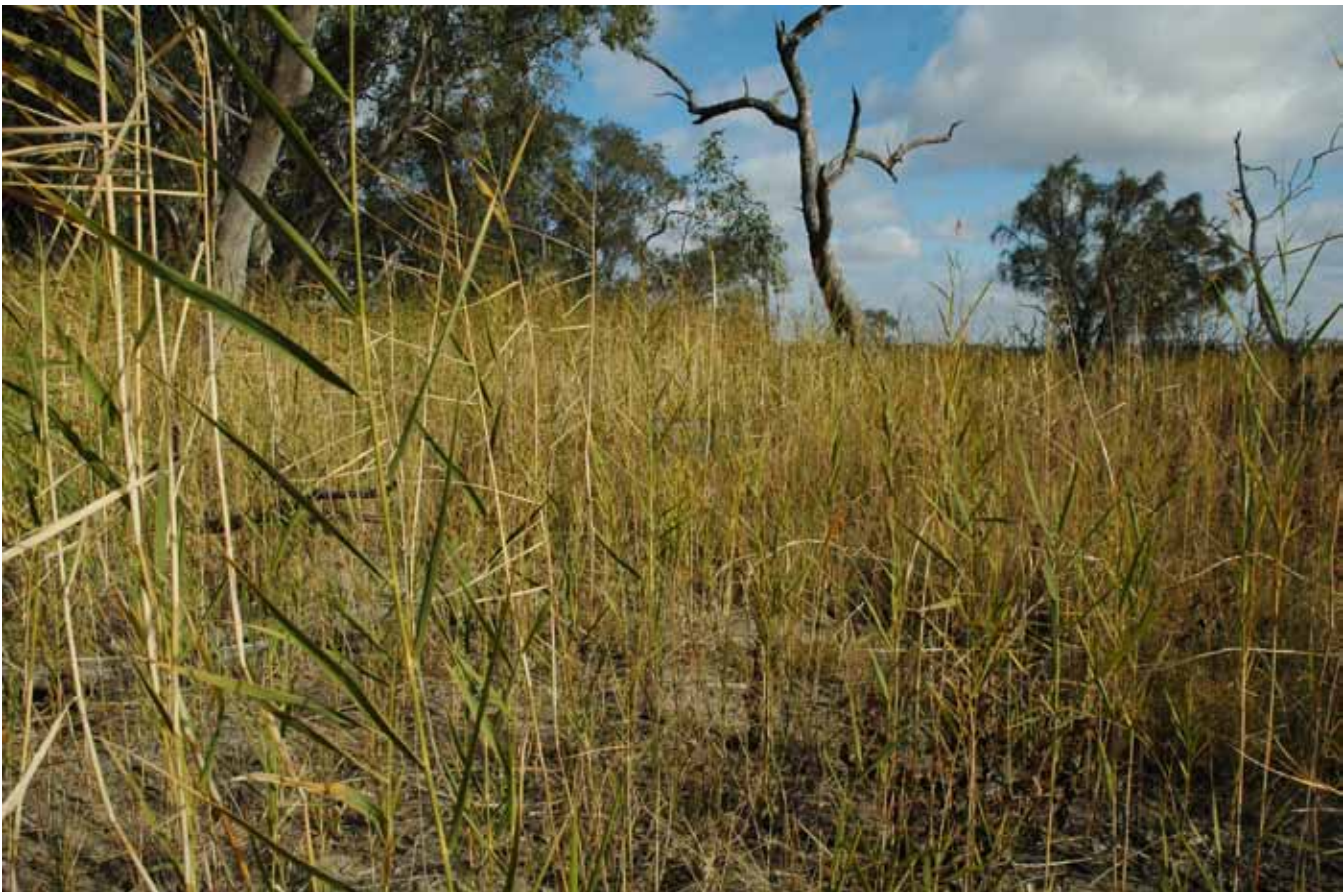
The Talgarry Barrier on 8th June 2011 at approximately 25.5 m AHD showing the substantial expansion of the common reed (*Phragmites australis*) fringe on the barrier at an elevation where numerous burial protection works exist.

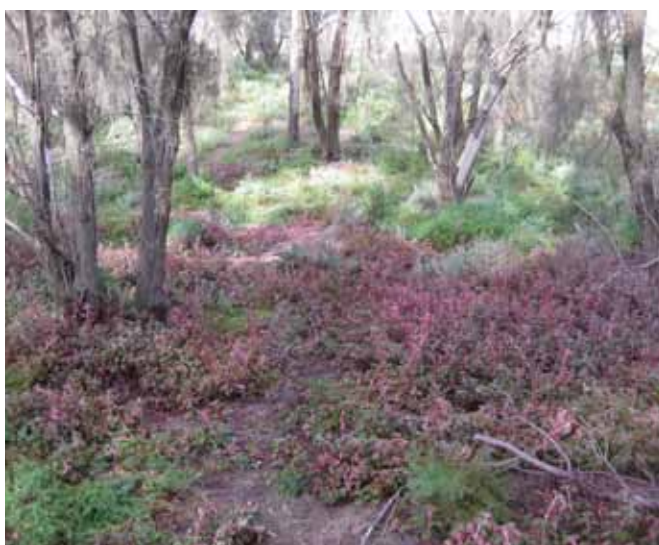
Sprayed horehound along the western foreshore
Photo courtesy of the SA Water Cultural Heritage Management team

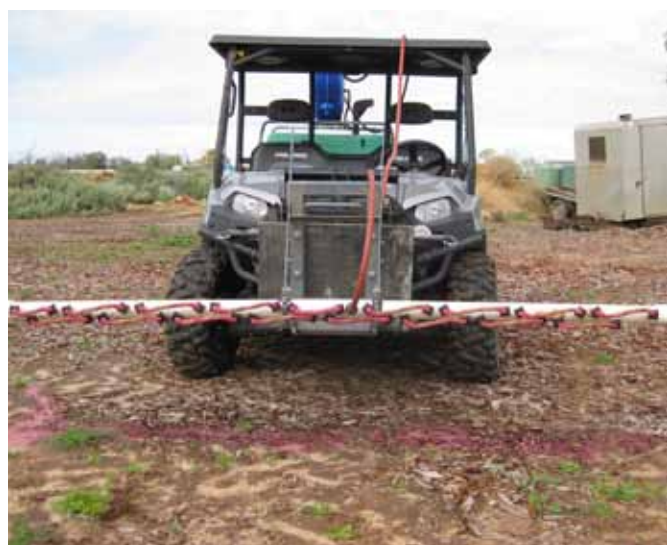
The new wick wand used to treat weeds
Photo courtesy of the SA Water Cultural Heritage Management team

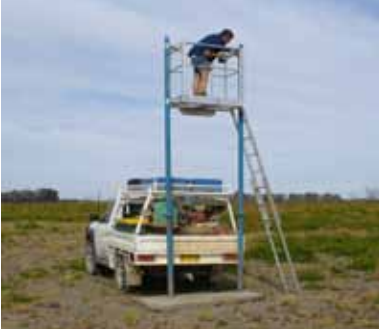
<p>Ground water monitoring bore hole with tower in the bed of Lake Victoria. Courtesy of Andrew Cannard</p>	<p>Compliance: Yes. The impact of Lake Victoria operations on neighbouring properties is assessed by monitoring groundwater levels beneath the River Murray floodplain to the east of the lake, and under adjacent higher areas surrounding the lake. Shallow groundwater levels can result in soil salination.</p> <p>Data loggers record groundwater levels continuously in 53 monitoring bores. Results from 15 selected representative sites have been presented in the 2010-11 report.</p> <p>Groundwater levels universally declined at a steady, yet modest rate over the extended dry period from 1999 to 2010. Very high rainfall in the most recent 18 months has caused groundwater levels to rise significantly faster than the declines earlier recorded. However current levels remain below or similar to levels recorded in 1999.</p> <p>Rainfall variation is the main influence on groundwater level change. The effects of Lake Victoria operations on groundwater levels in neighbouring areas has likely reached a long-term equilibrium, and any variation in the future will likely be governed by the medium to long-term deficit or surplus of rainfall.</p> <p>Action Recommended: Nil</p>

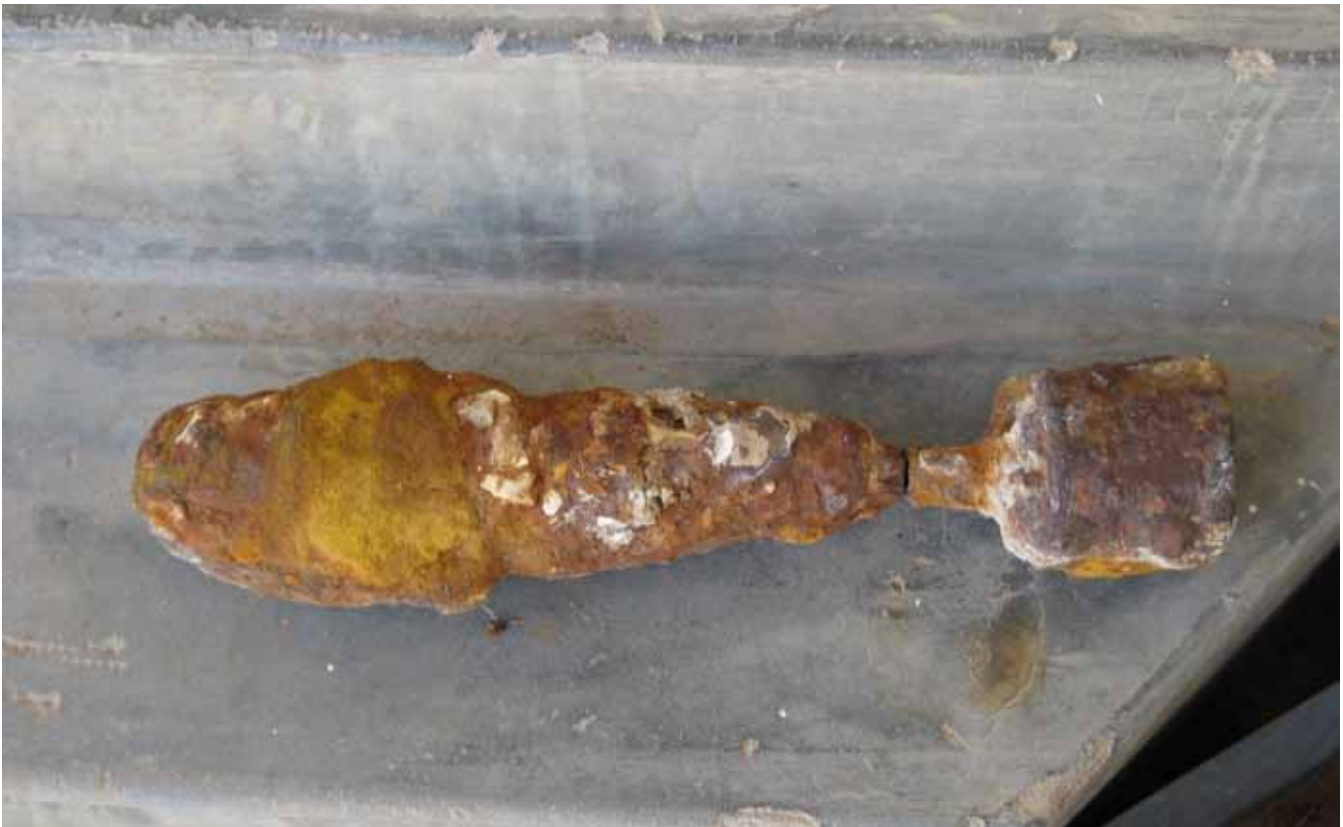
An old WW2 unexploded ammunition.
Courtesy of SA Water Cultural Heritage Management team

5. Add a new Works Procedure to address OH/S issues related to future discovery of WW2 fighter plane training ammunition.
 6. Add a Works Procedure to clarify the process to be undertaken to ensure that both the SA Water and A.H.I.M.S datasets always match by documenting the process for the transfer of data.
