Lake Victoria annual report 2017

1 January 2017 to 31 December 2017

The Annual Report is provided to demonstrate compliance with each of the Conditions contained in the Variation of AHIP issued in August 2015. This report provides a summary of activities that were undertaken for the 12-month reporting period from 1 January 2017 to 31 December 2017. The variation to the AHIP was approved by the NSW Office of Environment and Heritage (OEH) in August 2015. Unless revoked, this AHIP is in force until 4 August 2020.

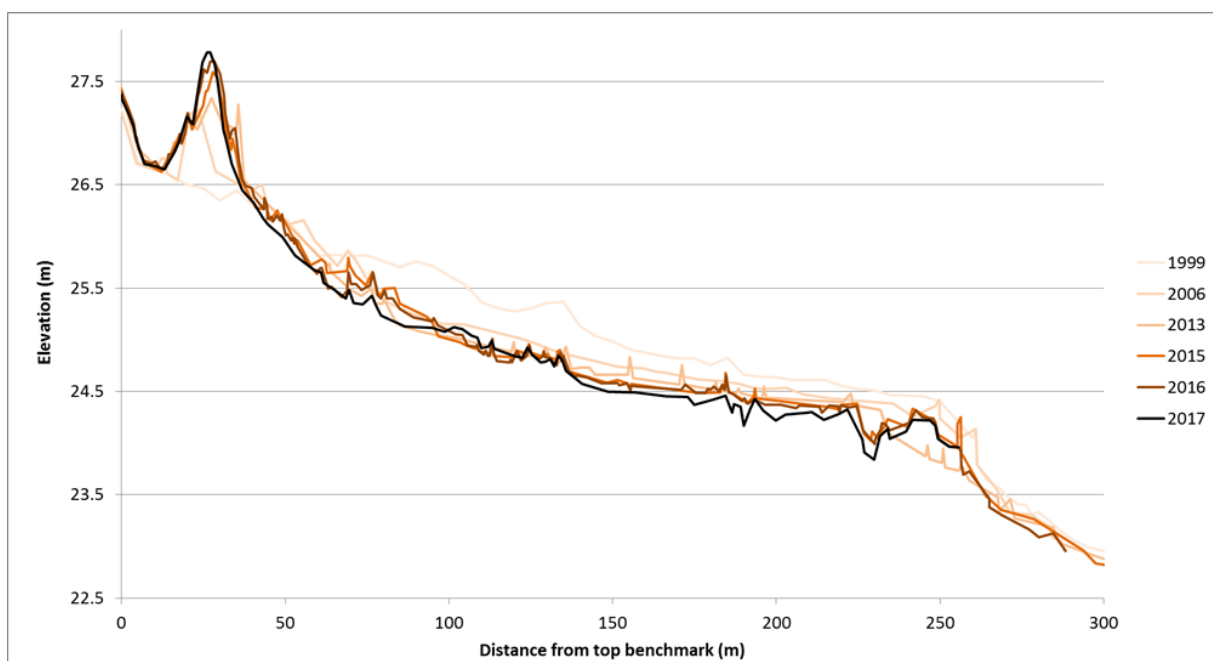
- In some areas, the movement of loose unconsolidated sand over the eastern lakeshore has occurred in the 2017 reporting period. Historical photo monitoring indicates that the eastern beach is largely devoid of vegetation and sand in this area has moved to and from this area

over time. This has exposed the more consolidated and solid Historically Undisturbed Sediment (HUS) which presently forms a 'pavement' across most the eastern foreshore.

Figure 5 Shoreline survey results for PS-28 (on the Eastern Beach) for 1999, 2006, 2013, 2015, 2016 and 2017 showing moderate change between years (Source: Daniel Haines, SA Water)

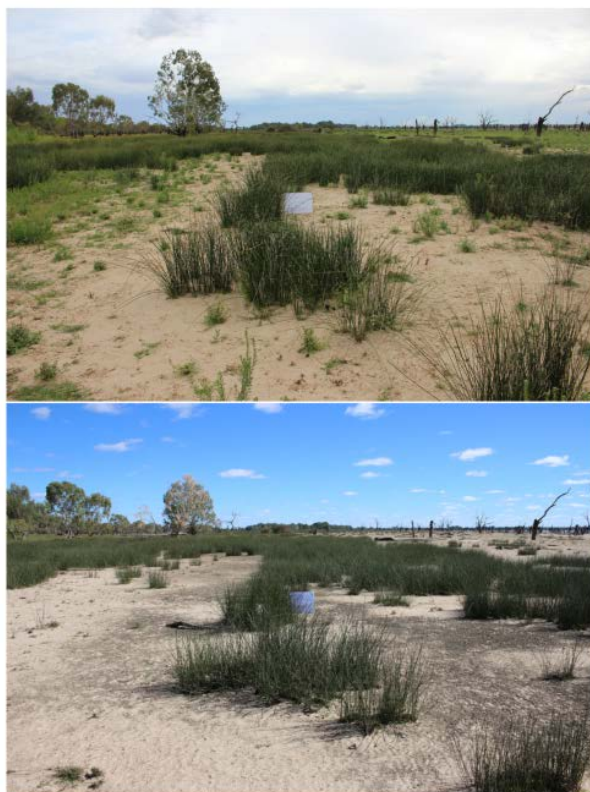
Figure 7 Persisting stands of spiny sedge on the Southern Lakebed around Snake Island (KSN09) at 25.0m AHD (top: April 2016, bottom: April 2017) (Source: Daniel Haines, SA Water)

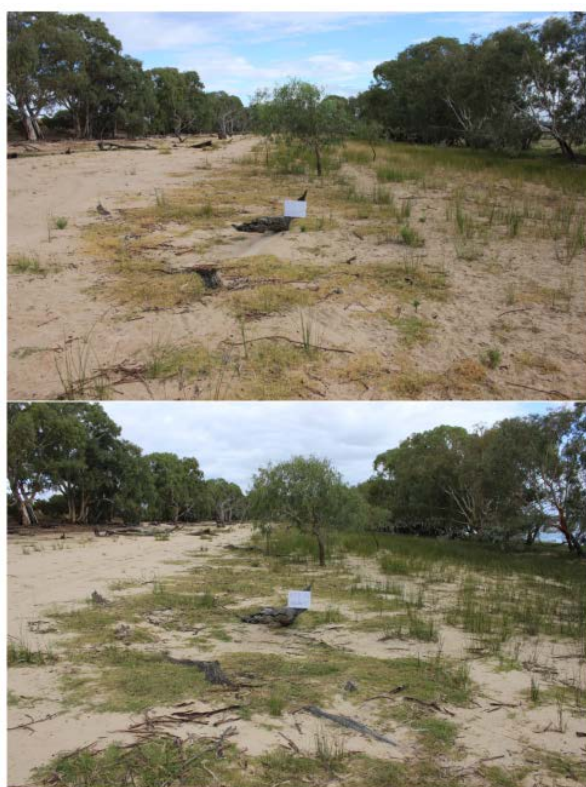
- Existing stands of spiny sedge in the Southern Lakebed, Frenchman's Islands, Talgarry Barrier and some areas of the western foreshore continue to persist across the foreshore above 24.5m and some vegetation exhibited some modest growth or improved condition (Figure 8).

Figure 8 Improvement of condition in couch grass and persisting spiny sedge behind Talgarry Barrier at photo point KT206 at 26.2m AHD (top: April 2016, bottom: April 2017) (Source: Daniel Haines, SA Water)

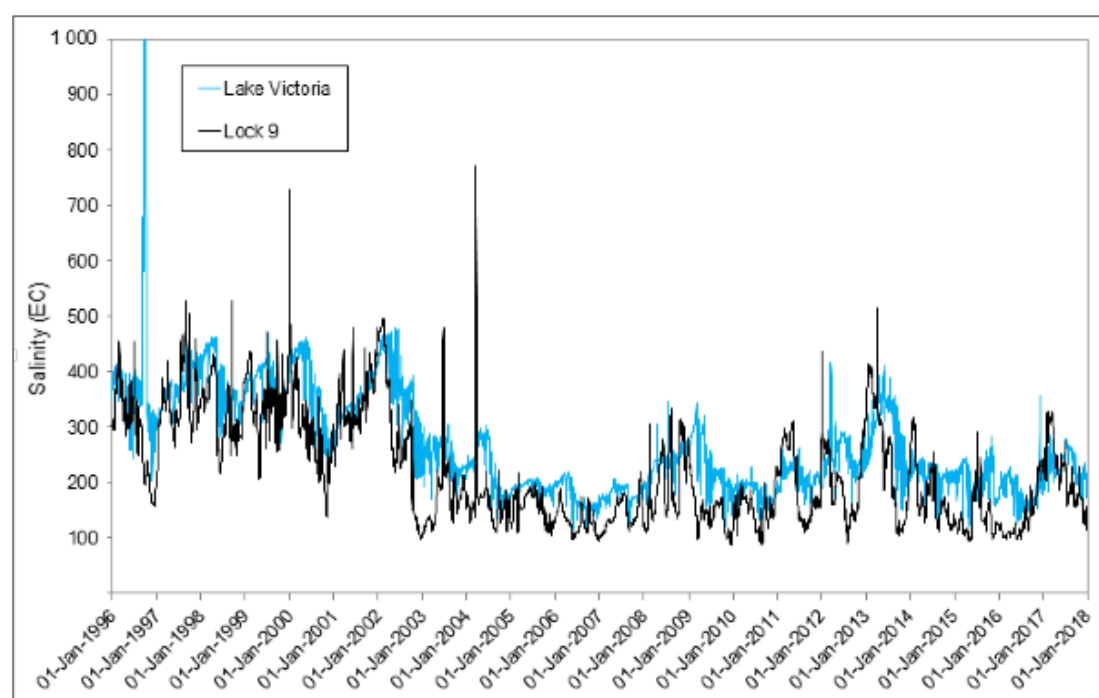
- Salinity, measured as electrical conductivity (EC), is measured daily (or continuously) at the Lake Victoria hydrographic stations (4260553 and 426502). It is important to consider long term trends in salinity data as groundwater generally moves slowly through the landscape and is influenced by a number of different factors.
- The long-term data set indicates that salinity in the Lake and in the River Murray is generally lower now than in the late 1990s when the initial AHIP was granted and the new operating strategy developed.

- The reduction over time is due to the operations of the salt interceptions schemes, improved irrigation and pastoralism practices, improved river operations and drier conditions. However even in recent wet years, salinity levels have not increased back to where they were in the late 1990s.
- The Lake salinity is still slightly higher than the nearest upstream River Murray location (Lock 9) indicating the higher saline groundwater, characteristic of the area, as it continues to enter the Lake.
- Salinity levels in Lake Victoria continue to follow the trend of lower EC from 2003 onwards into the reporting period (Figure 11).

Figure 11 Salinity levels in the River Murray at Lock 9 and in Lake Victoria since 1996 until present (Source: MDBA)

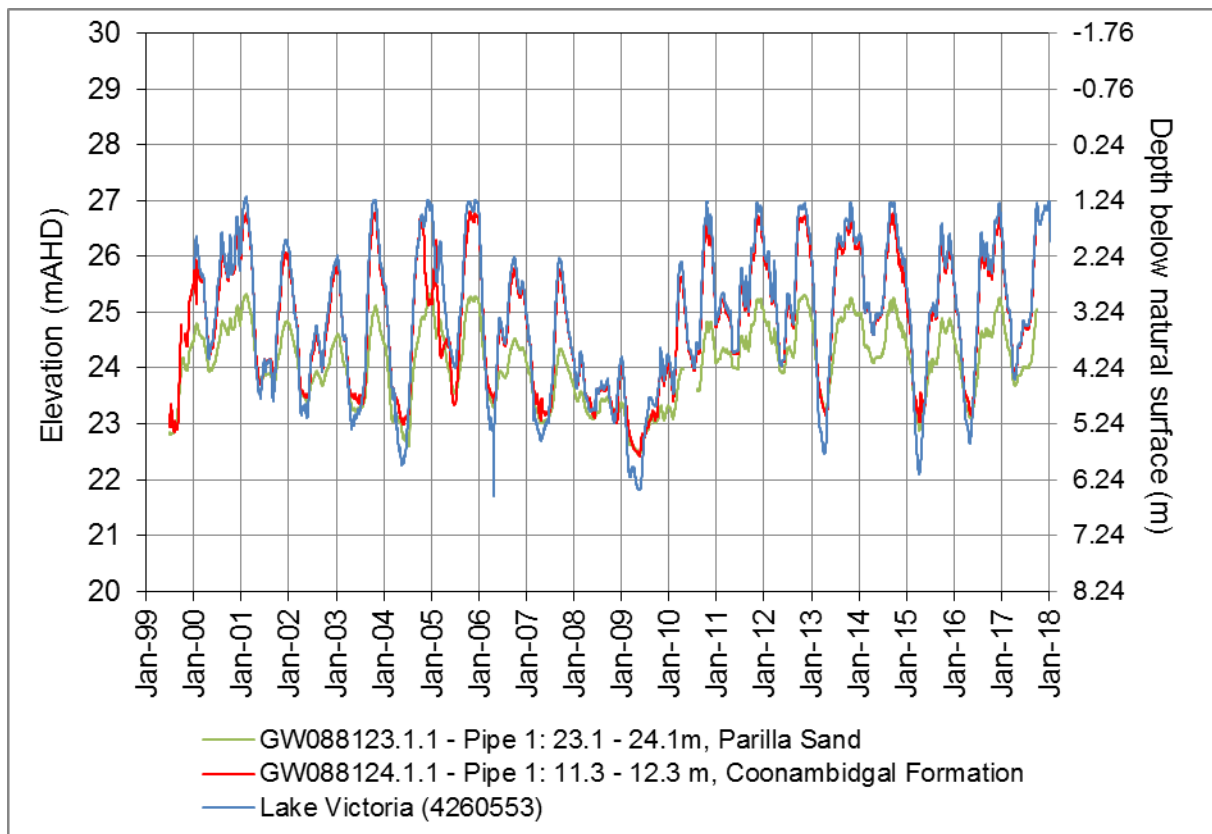
- Groundwater levels adjacent to the Lake or under the Lake itself continue to fluctuate in unison with the volume of water held in the Lake. Bores GW088123 and GW088124 are shown as examples in the hydrograph in Figure 16.

Figure 16 Hydrographs for monitoring sites GW088123 and GW088124 and Lake Victoria lake levels (Source: Water NSW)

- Outside of these fresh zones, the quality of the groundwater is brackish to saline then becoming hypersaline. Salinity increases with depth down the aquifer profile (Figure 18). The extent to which the Lake freshens the surrounding shallow aquifer (as indicated in Figure 17) does not appear to be as far reaching as the effect of the hydraulic pressure from the Lake as seen by the brackish nature of the Coonambidgal Formation in monitoring site GW088124, the same bore which seasonal mirrors Lake levels as shown in Figure 16.
