Lake Victoria annual compliance report 2019

1 January 2019 to 31 December 2019

March 2020

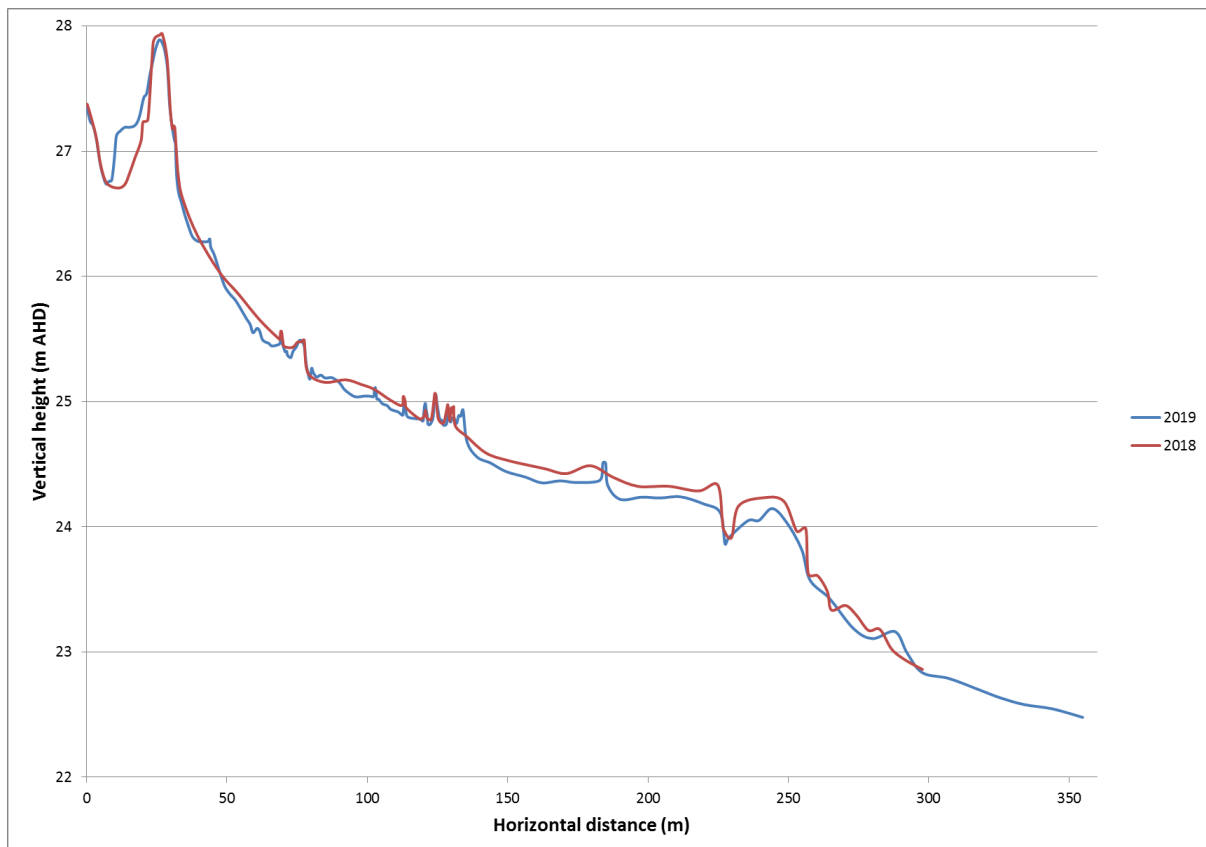
- Profiles on the eastern foreshore indicated that there had been a net loss of sediment between 2018 and 2019. This occurred in a series of bands parallel to the lakeshore and was likely part of the easterly migration of sediment anecdotally observed in this area. In some areas this erosion occurred in the vicinity of known burials, and so is some cause for concern.

Figure 2 - Shoreline profile 28PS on the eastern foreshore, showing a significant loss of sediment in three bands between 2018 (red) and 2019 (blue).

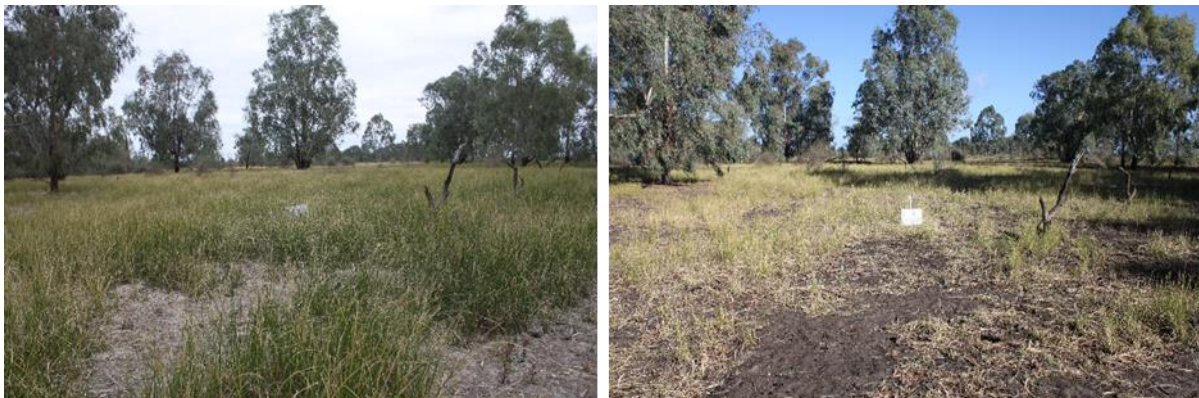
- There continues to be extensive coverage of spiny sedge and native liquorice on the eastern portion of the southern lakebed, however some grazing has occurred on East Moon Island since the 2017-18 monitoring period (Figure 4).
- Stands of phragmites on West Nanya Island are senescent due to prevailing drought conditions (Figure 5).

Figure 4 - Spiny sedge experiencing grazing pressure at East Moon Island, KEM03 (left: 2018, right: 2019)

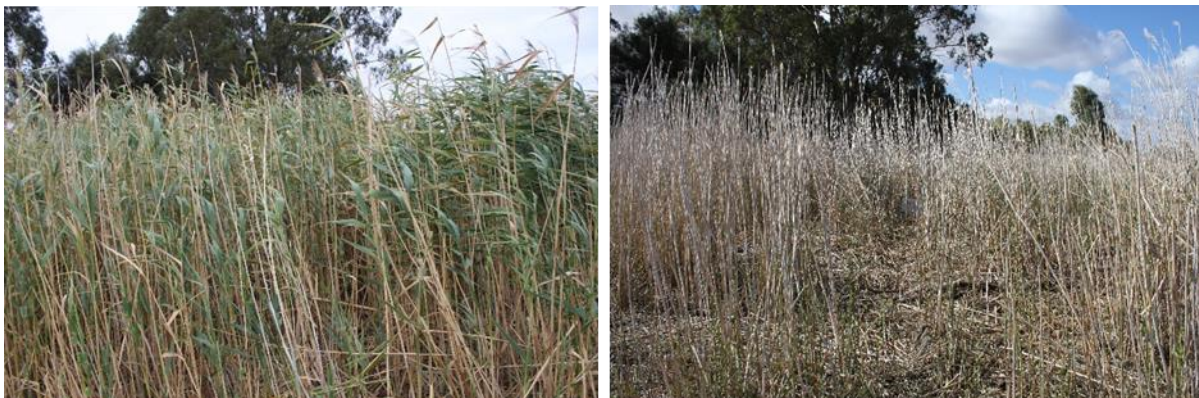
Figure 5 - A decline in condition of phragmites on West Nanya Island at KWN02 (left: 2018, right, 2019)

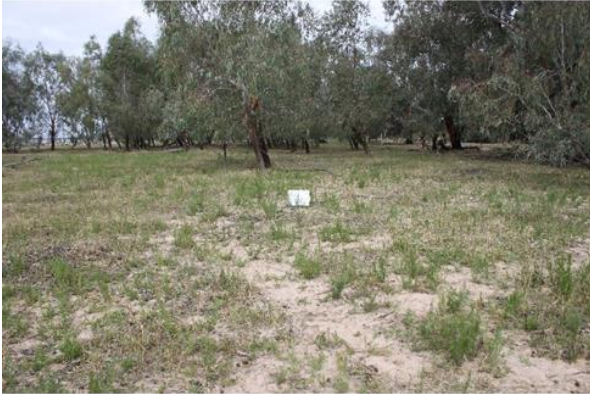
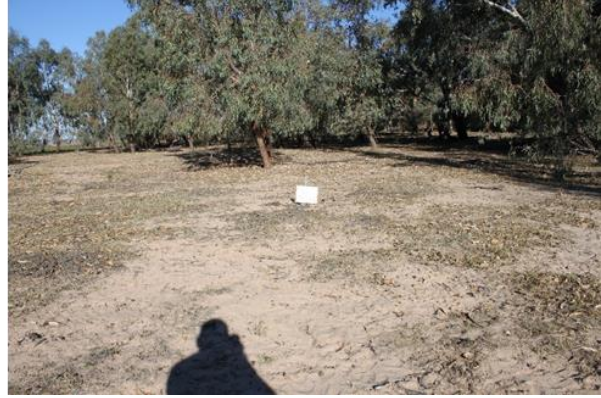
Figure 6 - There has been a decline in vegetation condition on the western foreshore at KVB07, likely due to grazing and dry conditions (left: 2018, right: 2019)

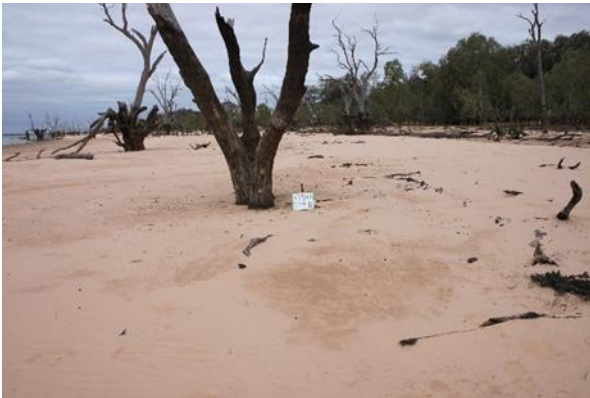
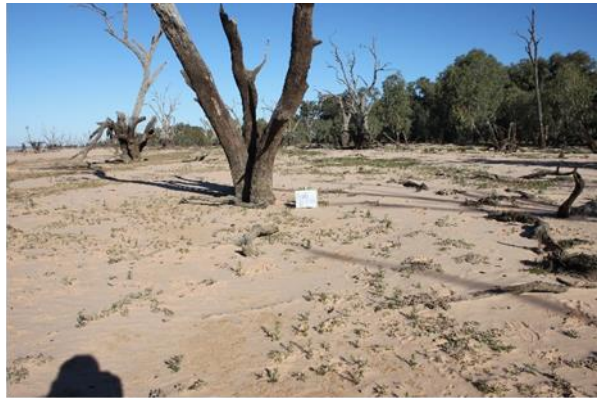
Figure 7 - There has been some growth of annuals on the lower western foreshore at KVB11 (left: 2018, right: 2019)

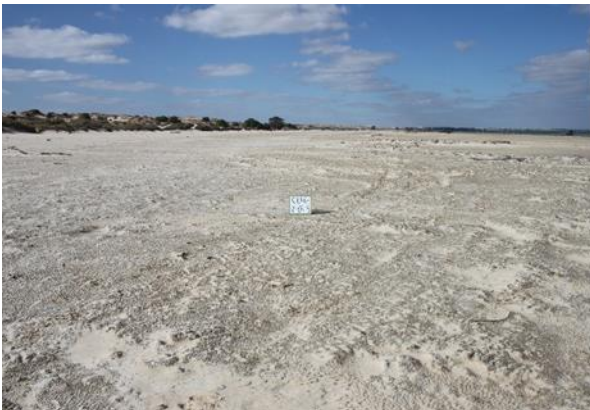
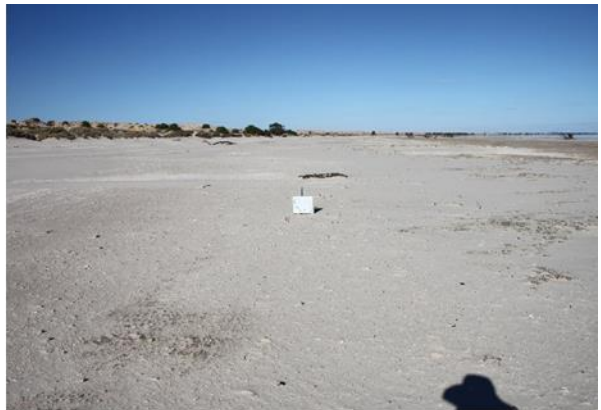
Figure 8 - There continues to be an absence of spiny sedge on the north-eastern foreshore at KNU05 (left: 2018, Right: 2019)

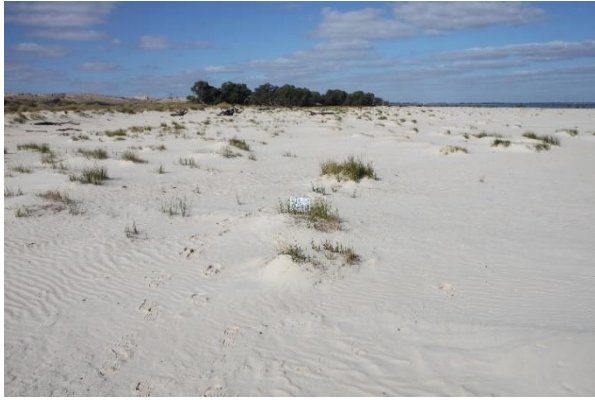
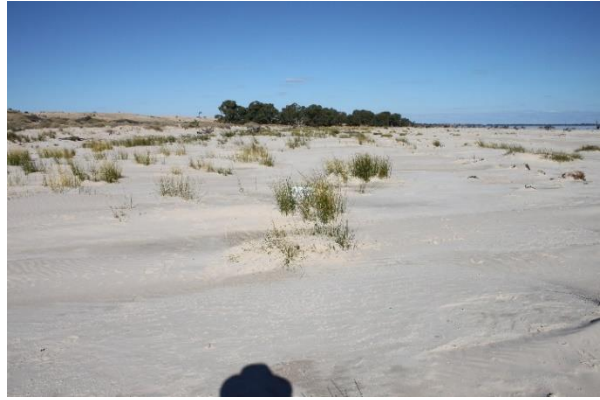
Figure 9 - Vegetation on the eastern foreshore appears relatively stable at KTN09 (left: 2018, right: 2019)

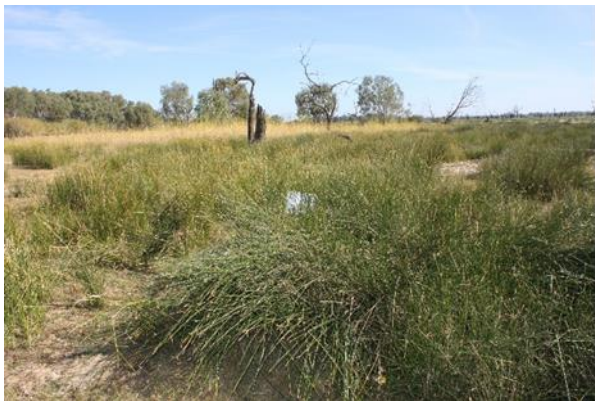
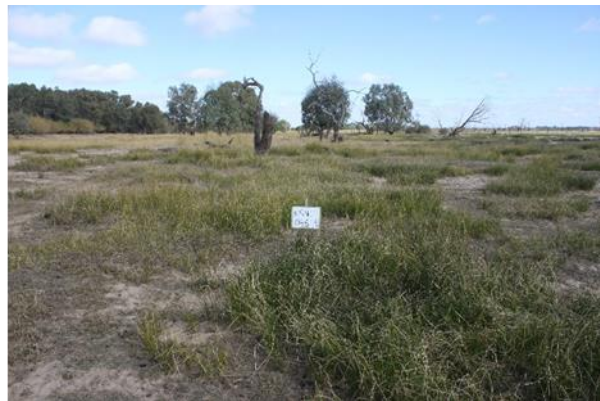
- Photo monitoring points indicate that while vegetation in some areas of the western foreshore has remained stable, other areas have been grazed and have declined in condition (Figure 6).
- There has been some expansion of annuals on parts of the lower foreshore (Figure 7).
- There has been little change on the northern foreshore, with vegetation still largely absent (Figure 8).
- Photo point transects on the eastern foreshore show that spiny sedge persists in this area. There has been a minor improvement in the condition of sedge (Figure 9).
- Photo point transects on the south-eastern foreshore show extensive grazing of spiny sedge around Snake Island (Figure 10).

Figure 10 - Evidence of substantial grazing has been detected in the vicinity of Snake Island at KSN08 (left: 2018, right: 2019)

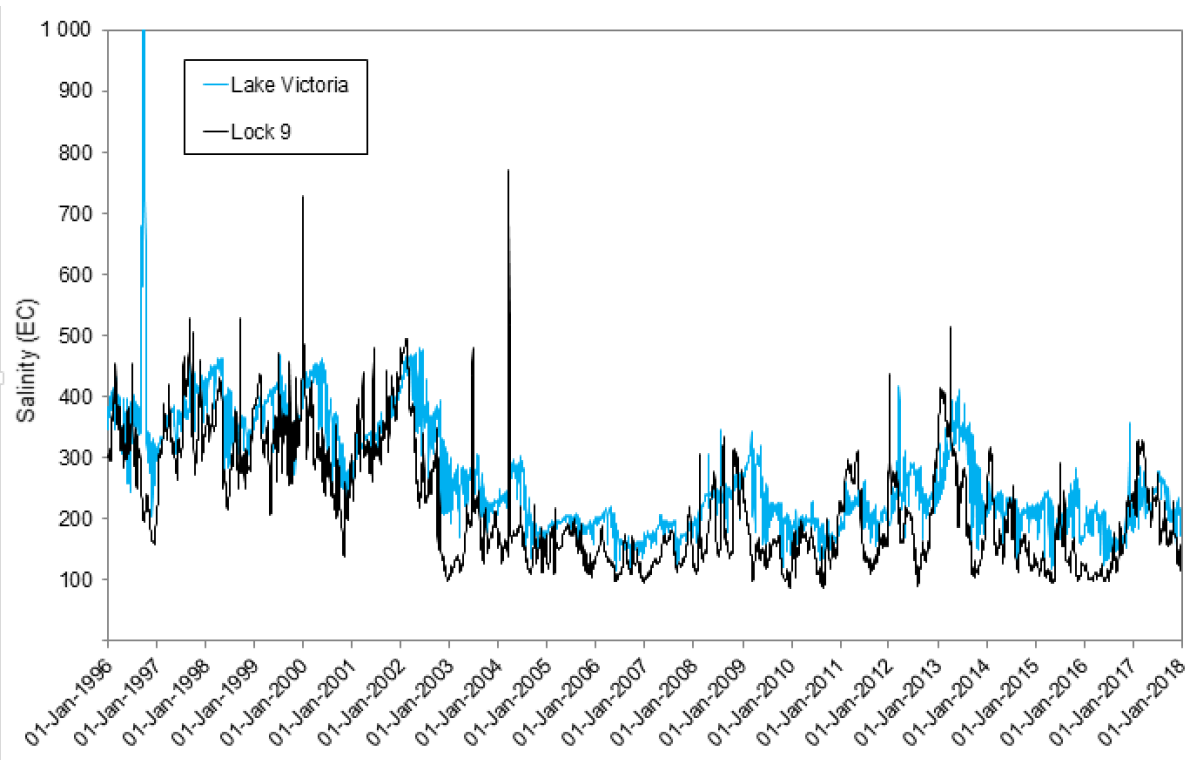
- Salinity, measured as electrical conductivity (EC), is measured daily (or continuously) at the Lake Victoria hydrographic stations (4260553 and 426502).
- The long-term data set indicates that salinity in the Lake and in the River Murray is generally lower now than in the late 1990s when the initial AHIP was granted and the new operating strategy developed.
- The reduction over time is due to the operations of the suite of salt interception schemes along the River Murray, improved irrigation and pastoralism practices and improved river and lake operations.
- The Lake salinity is still slightly higher than the nearest upstream River Murray location (Lock 9) indicating the higher saline groundwater, characteristic of the area, as it continues to enter the Lake.
- Salinity levels in Lake Victoria continue to follow the trend of lower EC from 2003 onwards into the reporting period.

Figure 13 - Salinity levels in the River Murray at Lock 9 and in Lake Victoria since 1996 until present.

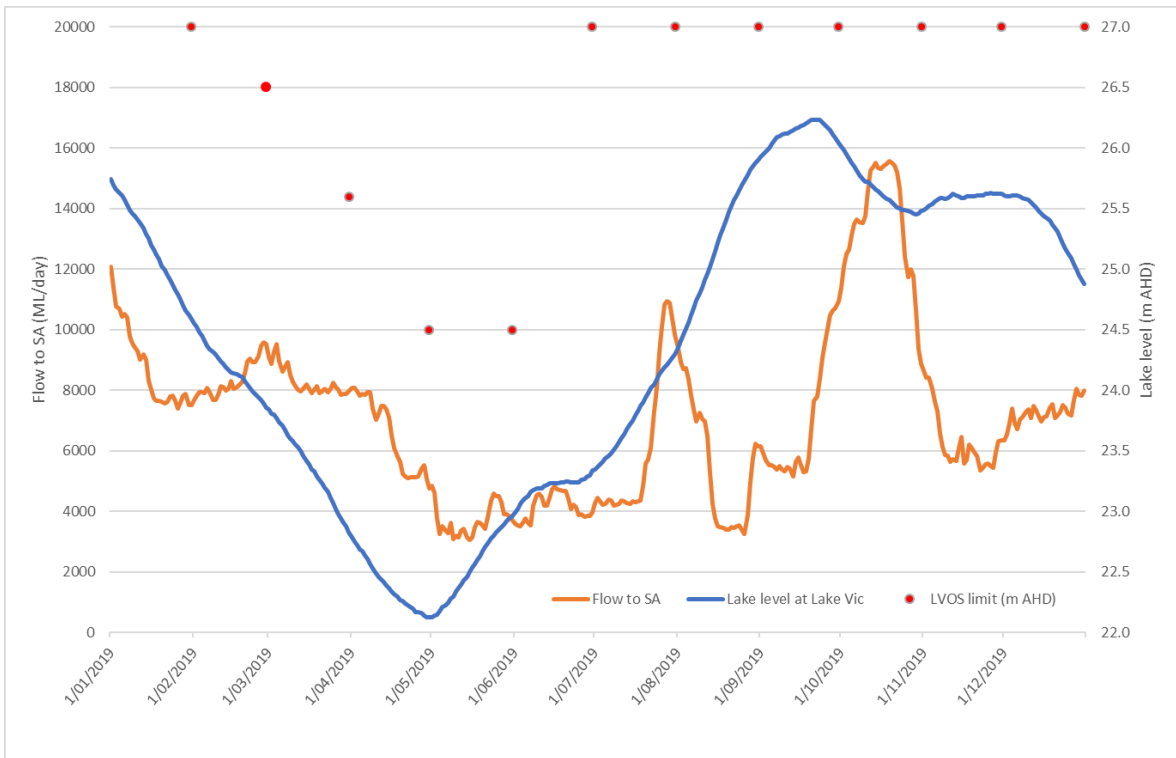
- The lake levels reached their lowest point of 22.13m AHD at the end of April and peaked at 26.23 m AHD on 20 October 2019 (Figure 14).

Figure 14 - Daily lake level at Lake Victoria storage in m AHD and flow to South Australia in megalitres per day for the reporting period (Source: MDBA).

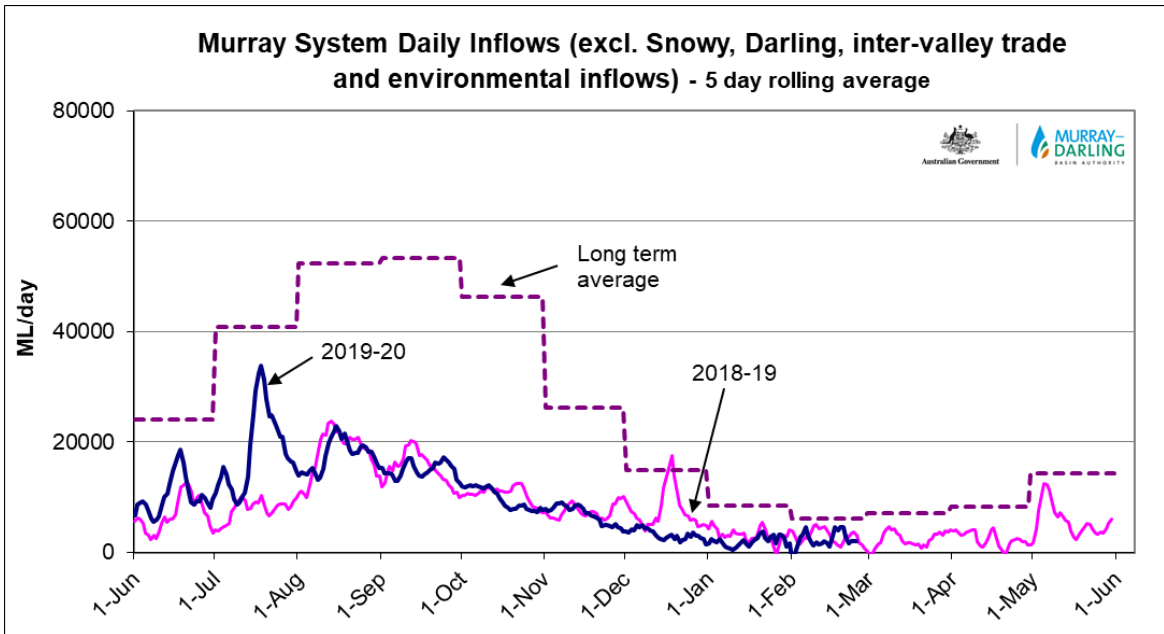
Figure 15 - Well-below average inflows in the Murray system between June and December 2018 (dark blue line) when compared to long-term average (dark purple line) (Source: MDBA).

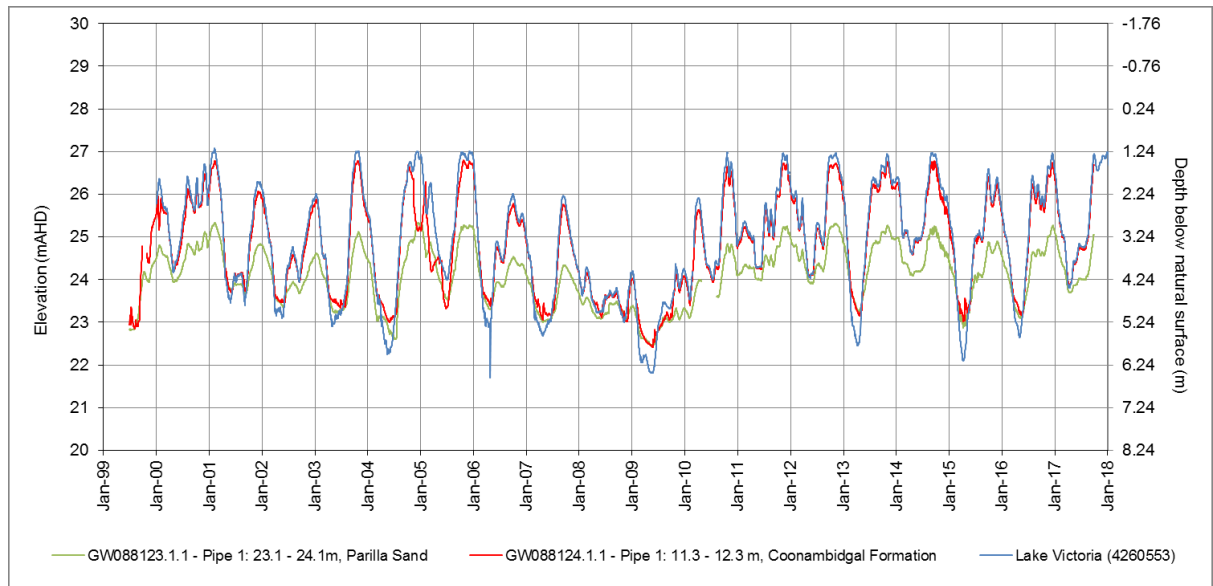
Figure 17 - Hydrographs for monitoring sites GW088123 and GW088124 and Lake Victoria lake levels (Water NSW).

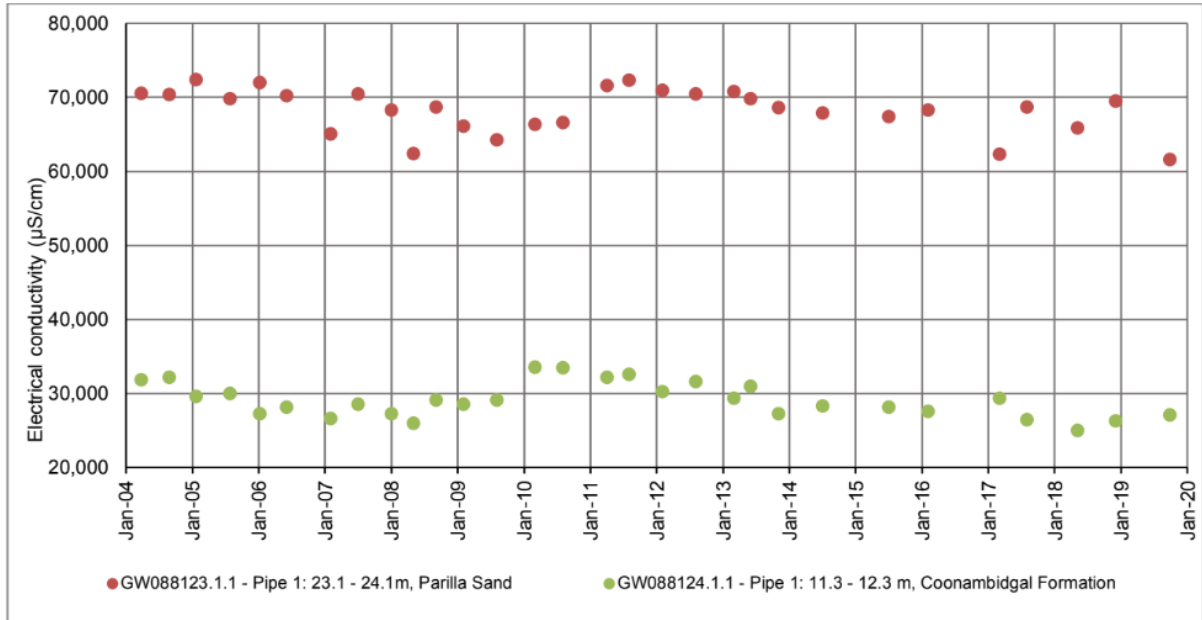
- The electrical conductivity in a nested monitoring site screening the Coonambidgal Formation and the Parilla Sand beneath the littoral zone of the Lake are shown in Figure 19. The deeper Parilla Sand unit has hypersaline groundwater consistently over the period of record and measured at 61,600 $\mu\text{S}/\text{cm}$ for EC in September 2019.

Figure 19 - Electrical conductivity at monitoring sites GW088124 (Coonambidgal Formation) and GW088123 (Parilla Sands).
